# CASE STUDY

Ram Jack Steel Piles Stabilize Building After Adjacen
Retaining Wall Fails

## Ram Jack Supports Apartment Building on the Edge

Marshall Township, Pennsylvania

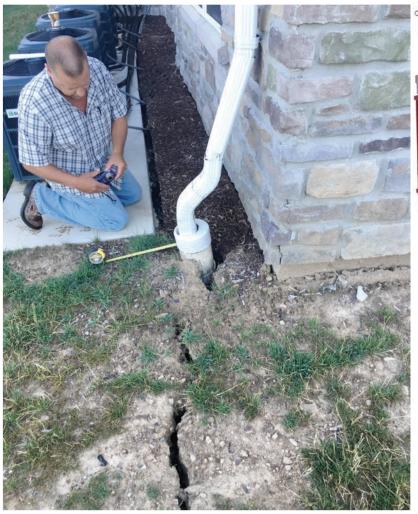
A four-story multi-unit housing building within a larger apartment complex sits adjacent to a 30-ft. segmented retaining wall. This location provided nice views for the tenants, but big problems lurked beneath the structure. The building settled 8-12 in. As photos from August 2016 show, large shear cracks were observed in the soil adjacent to the building as well as in the foundation (up to 7 in. in the soil and 1 ½ in. in the foundation). The segmented retaining wall also showed large cracks.

Photos taken one month later showed the extreme growth of cracks.

January 1, 2017 the retaining wall collapsed, revealing the steel piles installed by Ram Jack to be what was holding the structure secure. Excessive rain complicated repairs. The pond nearby was partially drained and a temporary road added to bring in 60,000 tons of gravel to shore the retaining wall. Underpinning would continue on the structure.

During careful excavation and installation, Ram Jack discovered areas where there were no footings below the structure. Interior load-bearing walls also didn't have footings. In addition to reinforcement and concrete added to shore the exterior sections without footings, the upper three stories had to be shored and footing placed beneath the walls. Ram Jack sideload brackets were incorporated into the new footing so the structure could be lifted after the footing

was placed. The structure was lifted 12 in. Void space beneath the floor slab was filled with poly foam. The property owner and engineer of record were adamant the building would have collapsed had Ram Jack not installed piles prior to the wall failing.
