# 2014 CASE STUDY

## BUSINESS OPERATIONS UNINTERRUPTED DURING REPAIR

Greenville, South Carolina

Landscaping Placement  
Causes Transpiration  
Leading to  
Foundation Settlement

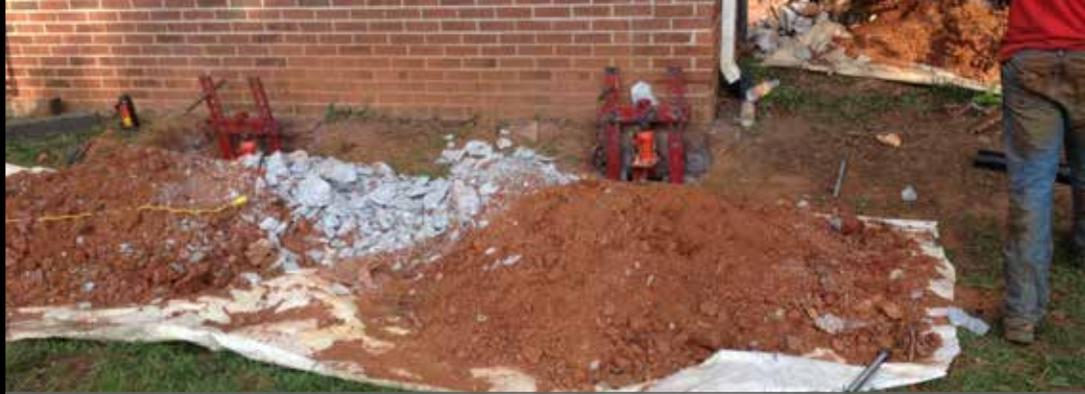
**AFTER:** Recovery of cracks in exterior brick

Nine driven piles with 4021 standard brackets were used to stabilize the structure. Each was driven to an average depth of 68 ft., lifting the foundation the maximum practical recovery distance of 1/2

in. and stabilizing the side of the building. In addition, the cracks in the brick were closed and the foundation was restored. The highly trained, professional crew of Ram Jack South Carolina used patented Ram Jack materials to complete the job in 1 1/2 days with little disturbance to the regular business operations being performed inside the building. In addition, the work and materials came with a lifetime warranty.

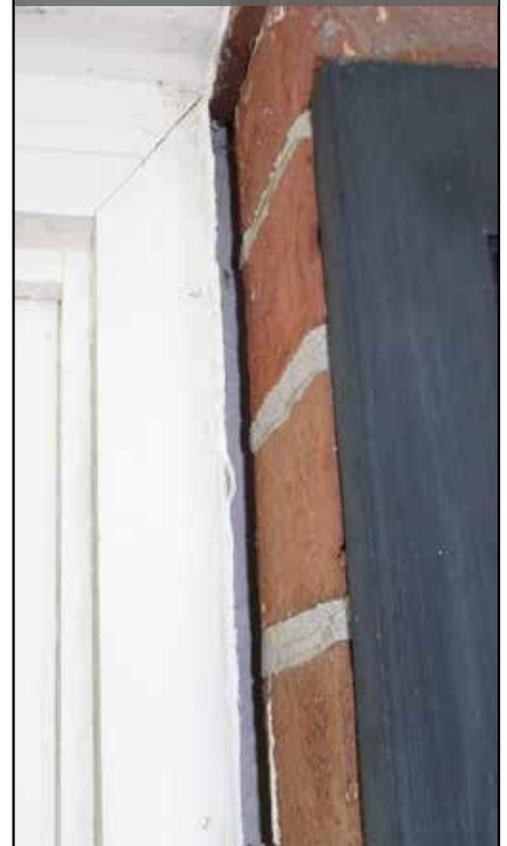
After a brief inspection by a Ram Jack professional, a number of problems became apparent. It appeared that years of foundation settlement and transpiration from landscaping near the foundation had finally come to a head. First, the brick exterior had multiple cracks, a symptom of an unstable, settling structure in need of repair. Second, a side window was separating from the brick keystone above, allowing unwanted airflow and rising utility costs. Third, wood trim was separating from the structure where the walls were settling and sagging.

**BEFORE:** Cracks in brick and around window sill

Ram Jack South Carolina proposed using driven piles to stabilize the structure to prevent any further, unwanted settlement. In addition, the piles would be used to lift sagging areas. This would not only ensure the safety and security of the structure, but it would also improve the appearance of the building, restoring its classic look.
