2014 CASE STUDY

STRUCTURAL INTEGRITY RESTORED

Irmo, South Carolina

Six Driven Piles
Recover Foundation
Damaged by Soil
Changes

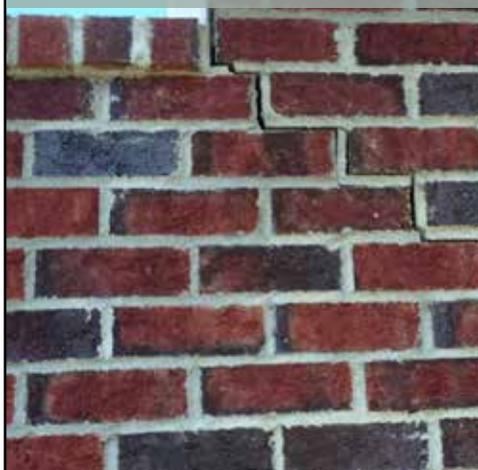
When the homeowner noticed a growing crack in her home's brick exterior wall, she called Ram Jack South Carolina. A Ram Jack inspection of the single-story, brick veneer home revealed a 7 in. stair-step crack in the rear, right corner of the structure running from the soldier brick at the bottom of a window down through the footer. In addition, a corresponding 1 in. drop of the structure in the area was noted. The cause of the failing wall appeared to be foundation settlement associated with soil expansion and contraction.

BEFORE: Crack in exterior brick

A team of professionally trained, experienced Ram Jack crew members installed six (6) 2 7/8" piles with standard brackets in strategic locations around the failing wall. The piles reached an average depth of 42 ft., and an average lift of 3/4 in. was achieved. The crack closed up nicely, and the failing wall's structural integrity was restored. The homeowner was extremely pleased with the work performed by Ram Jack South Carolina and eagerly signed off after a final inspection.

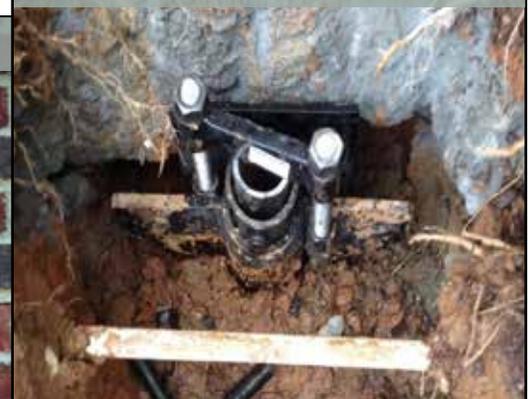
AFTER: 2 7/8 in. piles with standard brackets
