# 2014 CASE STUDY

Type: Residential | Issue: SC201410

## HOMEOWNER DISCOVERS UNSUPPORTED FOUNDATION

Four Helical Piles Installed  
to Stabilize Exterior Wall

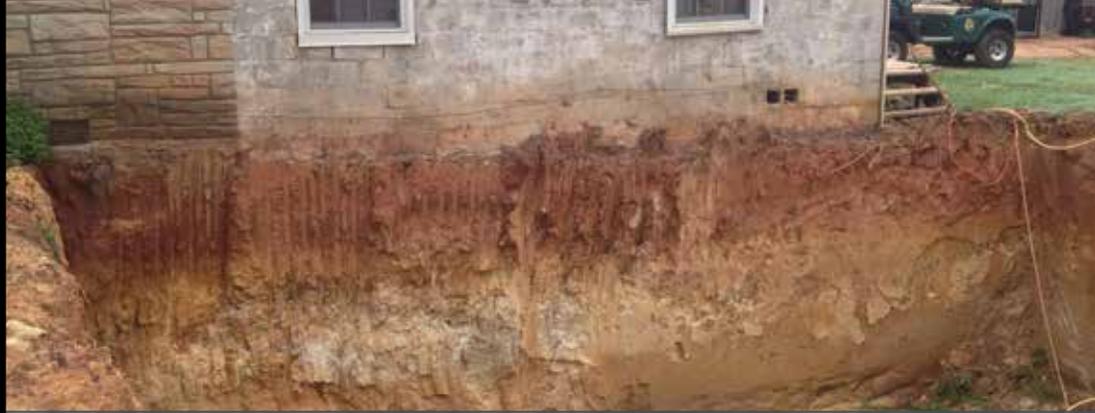
BEFORE: Unsupported foundation

After several weeks, the homeowner excavated a large amount of soil on one side of his home when he noticed that in just a few short weeks, the wall adjacent to the excavation site had settled around 1/2 in. A Ram Jack inspection revealed an unsupported foundation in the corresponding area, a settling and falling wall, and numerous significant cracks in the cinder block above the compromised region of the home. Intervention was absolutely necessary to avoid further dam-

Ram Jack proposed the installation of four (4) 2 7/8 in. helical piles with standard brackets and 7 ft. of angle iron between them to stabilize the exterior wall on the previously excavated side of the home. The helical piles would be used to restore the integrity of the structure and provide the needed support in the wall above the compromised area.

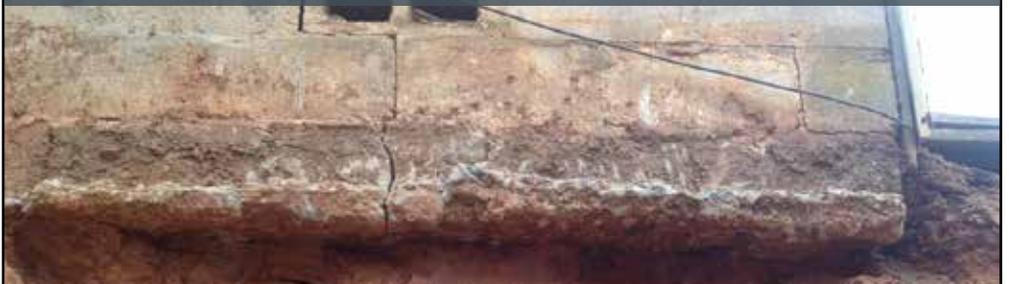
BEFORE: Crack in foundation

Four piles were successfully installed to an average depth of 35 ft. for complete recovery of the structure. In order to ensure the piles functioned properly, each was installed at an individual angle that maximized contact with the wall above and established adequate support below. Not only was the structural integrity of the home restored, but the cracks in the damaged wall were closed. The homeowner was completely satisfied with the job.

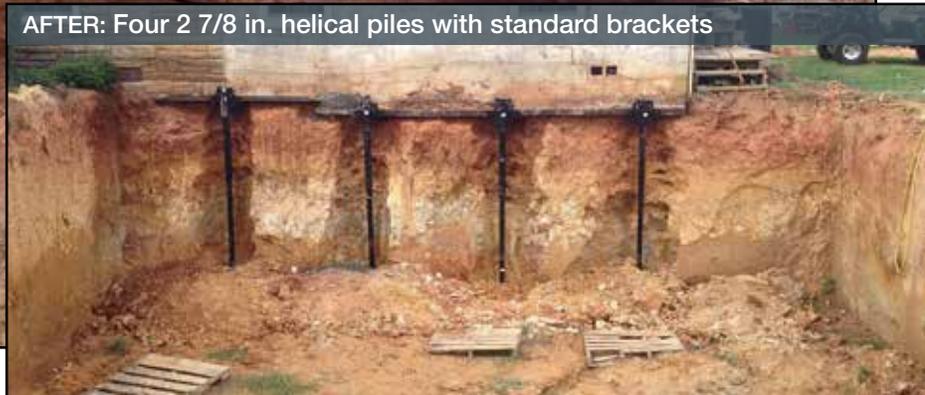
AFTER: Four 2 7/8 in. helical piles with standard brackets
