Type: Residential | Issue: SC201412

HOME SWEET HOME

Four Piles Restore
Structural Stability
to a Front Porch

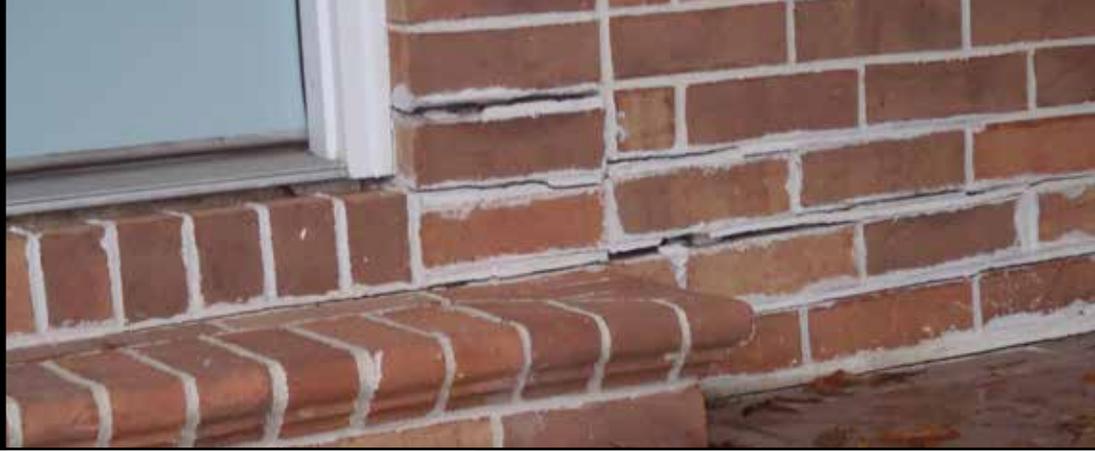
FRONT PORCH SEPARATION

A homeowner in Goose Creek, South Carolina, noticed a crack forming near her home's front door; she was anxious to get it taken care of as soon as possible. She contacted Ram Jack for the inspection and repair. A thorough inspection of the property confirmed the initial complaint. Just adjacent to the home's front door on the left side of the front steps was a large crack in the mortar of the brick wall. A similar fracture in the mortar was also found in the bricks on the right side of the front steps. Additionally, the entire front porch appeared to be separating from the main structure, as evidenced by a crack along the entire length of the brick where it meets the porch.

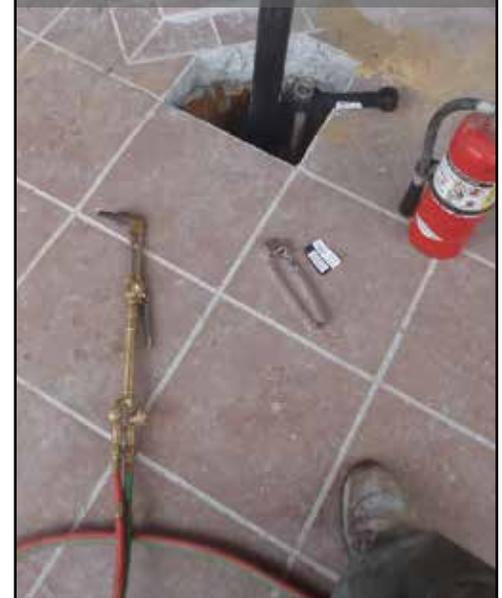
DURING: Minimal removal of concrete during installation

The Ram Jack South Carolina inspector proposed the installation of four helical piles. Tiles would be removed from the front porch, and the helical piles would be strategically located to lift the front porch back into place and restore the structural integrity of the porch and walls. The front porch would then be re-tiled, concealing the newly installed helical piles.

Four (4) 2 3/8 in. diameter helical piles with slab brackets were installed as proposed. The piles reached an average depth of 10 ft. and lifted the front porch and damaged wall 1/2 in. for a complete

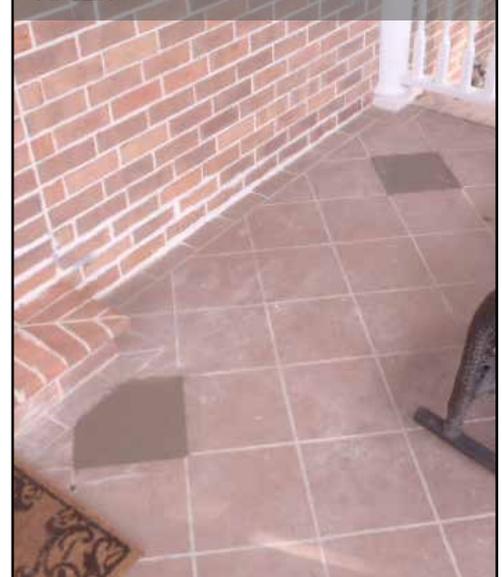
AFTER

recovery from the foundation settlement damage. Additionally, the fractures and cracks in the brick were closed, restoring the home's beauty along with its structural integrity.
