2015 CASE STUDY

Type: Residential | Issue: SC201506

**Helical Piles
Recover Porch
Slab Sinking
Due to Poorly
Compacted
Soil**

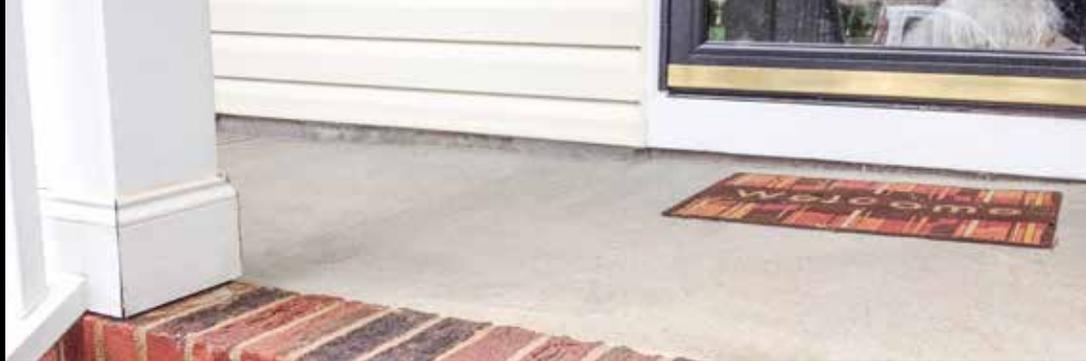
BEFORE: Porch slab settled up to 2 in., creating a gap between the slab and the house

The homeowners contacted Ram Jack South Carolina when they noticed the concrete floor of the porch, which had once been level, had begun to settle. Ram Jack sent a foundation specialist, who found that the porch slab had fallen as much as 2 in. at the center. Presumably, the soil beneath the porch had not been properly compacted prior to its con-

struction, and with the increased weight of the concrete slab, the soil settled, bringing the porch with it.

After a thorough inspection, Ram Jack South Carolina professionals proposed the installation of three helical piles. These piles would be used to lift and stabilize the sinking concrete slab.

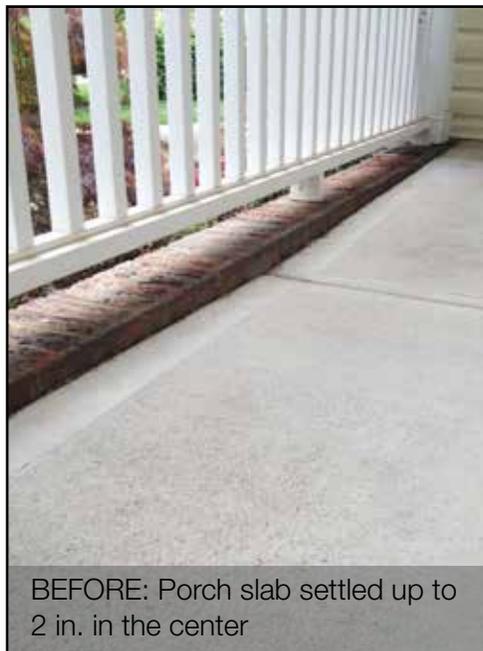
BEFORE: Porch slab settled up to 2 in. in the center

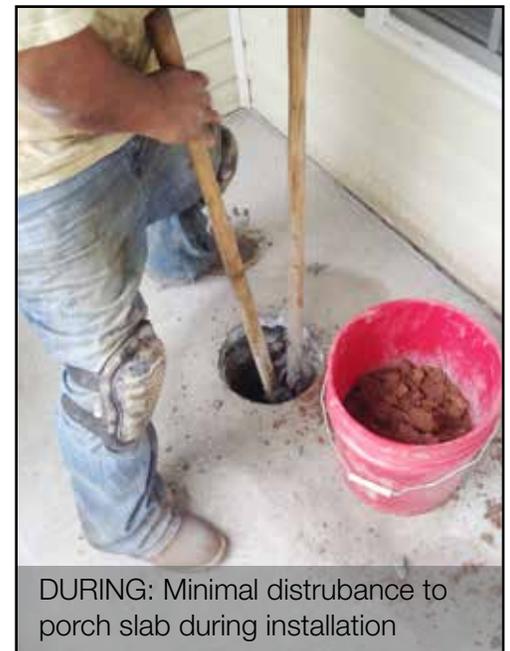
DURING: Minimal disturbance to porch slab during installation

When the crew arrived to install the piles, they noticed a new stair-step crack in the front, right corner of the concrete slab, indicating that the corner of the porch was settling as well. Knowing the corner of the porch slab would also need to be repaired, the crew came up with a new plan. In addition to installing the three proposed helical piles as scheduled, the crew added two helical piles to the porch's corner a few weeks later. When the job was finished, the porch was lifted to maximum practical recovery, the cracks were lessened, and the stability of the porch matched the beauty of the home.
