Ram Jack® Case Study

Hotel Indigo Addition - Scottsdale, AZ

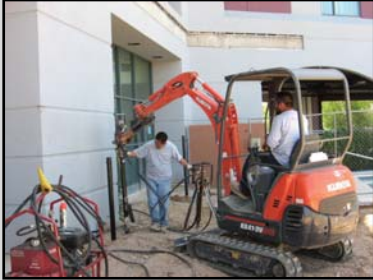
Driving helical pile

Solution: It was determined that the installation of new construction helical piles was the best option. The equipment required was small enough to fit into the tight spaces. The Ram Jack engineers were able to work with the structural engineers to design a pier system to carry the required loading of the steel support columns.

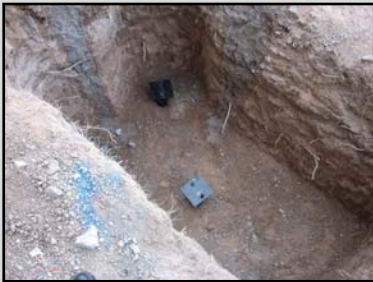
Pile cap ready for reinforcement and concrete

Conclusion: A total of 13 helical piles were installed with new construction brackets with bearing plates. The reinforcement was placed in the pile cap and attached to these brackets prior to the concrete pile cap being placed. The Ram Jack helical pile system was installed in 3 days and not only solved their problem but was able to put the project back on schedule.

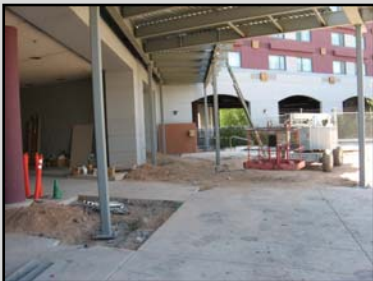
Columns installed on pile caps

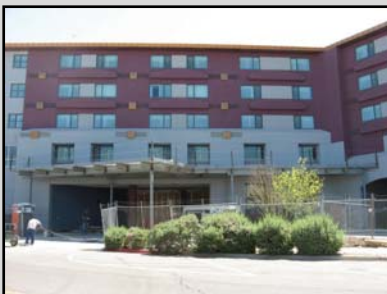
Framework ready to install deck
