# CASE STUDY

## 13<sup>th</sup> Street Bridge Project

Gainesville, FL

Installer: Ram Jack Solid Foundations • Gainesville, FL • 386.462.3001

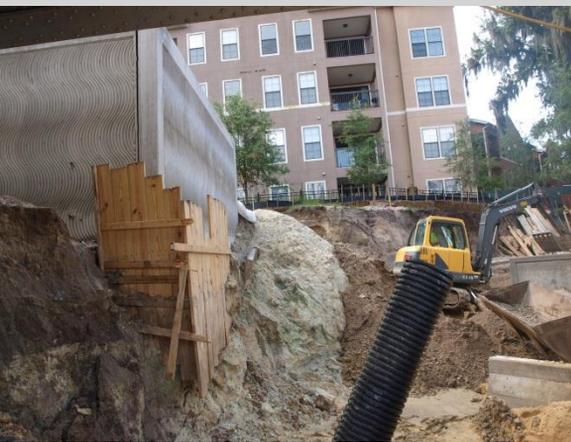
During tropical storm Debbie, the foundation of one of the newly constructed landing/gathering areas was undermined. The heavy rains eroded a large area of bearing soil from beneath the foundation of the structure. The loss of bearing soil caused the structure to settle in the order of 1 to 4 inches. The construction of the structure consisted of 1-foot thick concrete walls that were 12-feet tall bearing on a spread footing foundation. Because of the settlement, the walls became misaligned and several large stress fractures developed. The City of Gainesville needed a quick and perminate solution before the entire structure was lost so they contacted the experts at Ram Jack.

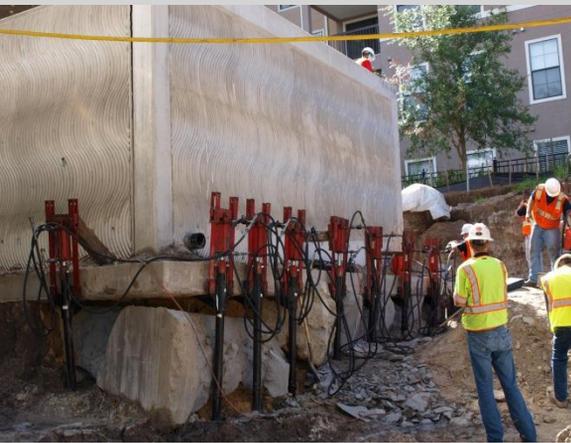
As can be seen from the photographs to the left, some of the piles had unbraced lengths up to 5-feet above grade. Ram Jack's patented internal threaded connection, which is included in Ram Jack's ICC-Evaluation Service Report (ESR-1854), allows the exterior surface of the pile to be smooth and homogeneous. This allows an exterior sleeve of infinite length to be placed over the upper portion of the pile. The length of the exterior sleeve is custom designed for projects like these to increase the stiffness and bending stress resistance of the pile at it's critical section. This allows the pile to support higher design loads and longer unbraced lengths than other systems while still using a smaller more economical pile.
