CASE STUDY

Rabobank

Calexico, CA

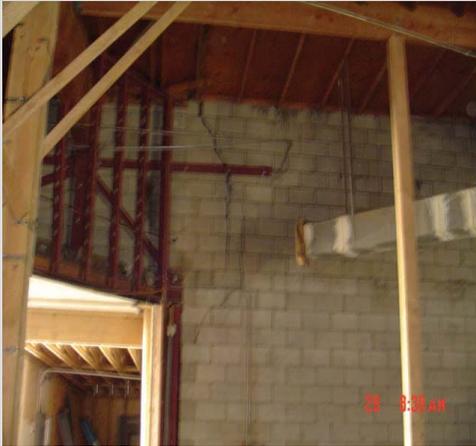
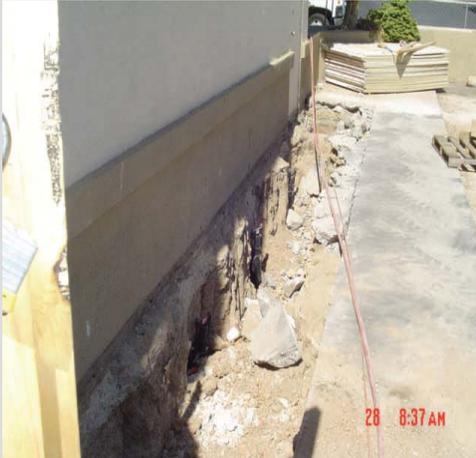
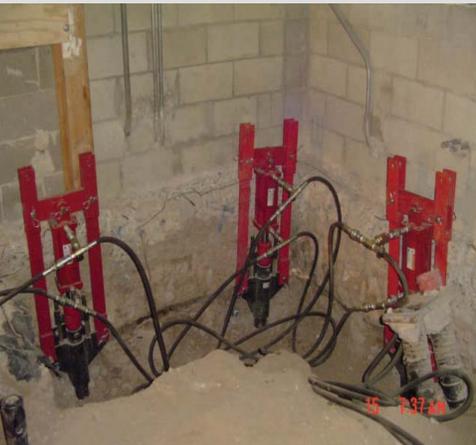
Situation: In the early spring of 2007, Scott Kremke and Ram Jack of California were contacted for a bid on the repairs needed on a Rabobank property in Calexico, California. The bank building had a large crack across the floor, and the windows and doors were misaligned. The bank owners were concerned that the vault might become inoperable due to the building settling. Working with Grenier Engineering of Phoenix, Arizona, Ram Jack of California proposed a repair design consisting of 70 Ram Jack® Deep Driven Steel Piers on the perimeter foundation of the structure and 30 Ram Jack® Helical Piers on the interior slab.

Solution: Due to the condition of the structure and the extent of the repair and remodeling plan, a complete relocation was required. Earlier attempts at repairing the structure presented some challenges within the scope of the project. One of the support beams for the roof system was placed directly over the rear opening and was causing the header to fail and had opened a large crack in the above wall. During the concrete removal for the pier locations on the interior slab, the header and roof system began to go into further failure. A design and repair of the failing header and roof system was installed and a decision was made to remove the entire interior floor system and use the 30 Ram Jack® Helical Piers as preconstruction anchors. The loads created by the 3' by 3' footing system and the 25' masonry walls with the free span roof presented a challenge for Ram Jack of California to perform the required lifting of the structure. A Ram Jack® Manifold Lift System was purchased for this. The lift system allows for a uniform lift to be made at several pier locations. With an ultimate lift capacity of 50 kips per location, most residential and commercial structures are within the design capacity of the system.

The Ram Jack® Deep Driven Steel Piers were driven to a final depth of 60' with an ultimate capacity of 60 Kips and the Ram Jack® Helical Piers were driven to a final depth of 20' with an ultimate capacity of 40 Kips. With all of the piers installed, a lift was made on the structure using the Ram Jack® Manifold Lift System. The final elevation recovery was 3.5", leveling the front of the structure with the built-in concrete vault system. This corrected the misaligned windows and doors and allowed for the new slab to be installed without any slope.
