2014 CASE STUDY

Custom Support Brackets
Allow Maximum Support,
Minimal Material Costs, and
Efficient Installation

VILLAGE SQUARE APARTMENTS | REPAIR

Russellville, Alabama

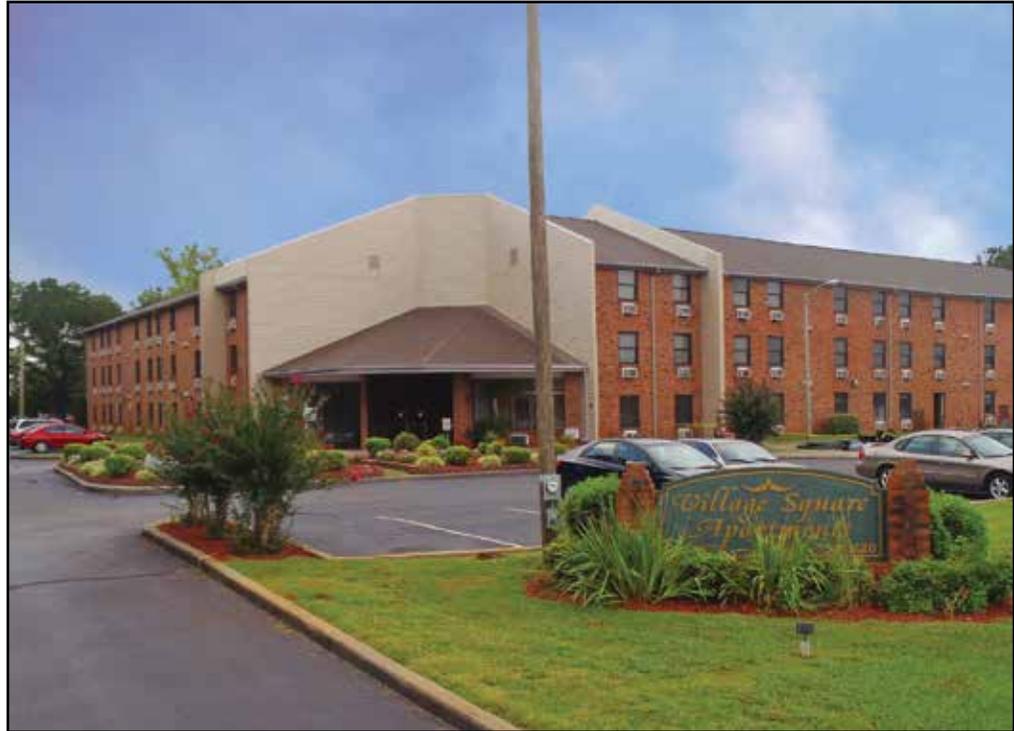
A vintage, three-story, wood-framed structure with brick veneer built in 1981, the Village Square Apartments had extensive foundation settlement and corresponding damage in the center of one of its multiple wings. Soil analysis revealed that it had been built on two separate layers of imported soil. The upper layer measured 8 ft. deep and had been placed over existing fill. Underlying the top layer was another layer of soil that measured approximately 30 ft. deep. Unfortunately, this deep layer of soil was not suited to support the massive apartment building, and, over time, the structure began to settle. As the soil settled, the building settled with it, causing multiple cracks in the brick veneer, uneven floors, and windows and doors that wouldn't open and shut properly.

Alabama Ram Jack engineered and proposed an alternate solution in which each pile would be placed a maximum of 7 ft. apart. To account for the building's weak footings, Ram Jack engineers designed custom 4 ft. wide support brackets to cradle the footings, minimizing unsupported areas and allowing maximum support with minimal material costs, labor fees, and time spent for installation. This provided a cost-effective solution for the owner while also decreasing the time frame for the repair.

The owner accepted the proposal and Alabama Ram Jack went to work. The custom brackets worked perfectly, and the plan was implemented without any unforeseen delays or obstacles. In the end, sixty (60) piles [28 driven piles and 32 2 3/8 in. helical piles] were installed on the interior to an average depth of 25 ft., and fifteen (15) piles [14 driven piles and one 2 7/8 in. helical pile] were installed exteriorly to an average depth of 38 ft., achieving a maximum practical lift of 2.5 in. This not only alleviated the binding windows and doors, but it closed unsightly cracks and evened the grade of the floor so the tenants could move back in and the owner could start collecting his rent again.
