Type: Residential | Issue: AL201403

RAM JACK TO THE RESCUE

Building a Retaining
Wall to Secure a
Classic Home From
Flood Damage

FOUNDATION & RETAINING WALL RECOVERY

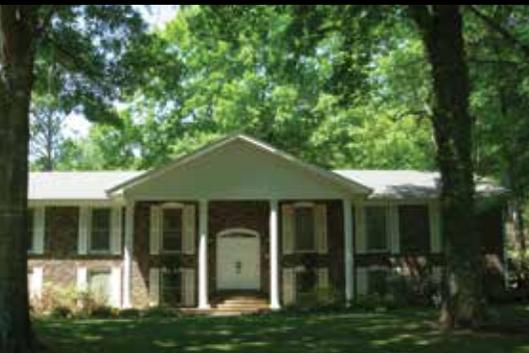
Cracks in exterior due to flood-induced settling.

The home had already been settling prior to the flood damage. In fact, only five years prior, another foundation repair company had installed helical piles to lift a settling area of the home. Cracks were visible in the exterior brick walls, and a growing fissure in the interior floor was growing too large to ignore. The homeowner was hoping Ram Jack could provide a permanent solution.

Alabama Ram Jack proposed replacing the existing helical piles with deep-driven steel piles that would penetrate below any seasonal water and potential flood damage. Additionally, Ram Jack proposed the construction of a new restrained-concrete retaining wall to replace the existing one. Helical tie-back anchors would be installed to provide added lateral support.

Ram Jack successfully executed its plan, installing 10 helical piles with interior slab brackets to an average depth of 10 ft. inside the home and a combination of 12 driven piles with side load brackets and 10 helical piles to an average depth of 30 ft. around the home's exterior. These new piles replaced the existing ones, which previously reached a depth of only 5 ft. The structure was lifted 1.25 in., closing the exterior cracks in the brick wall and providing the structural support the home needs to withstand normal wear and tear and unforeseen circumstances in the future.

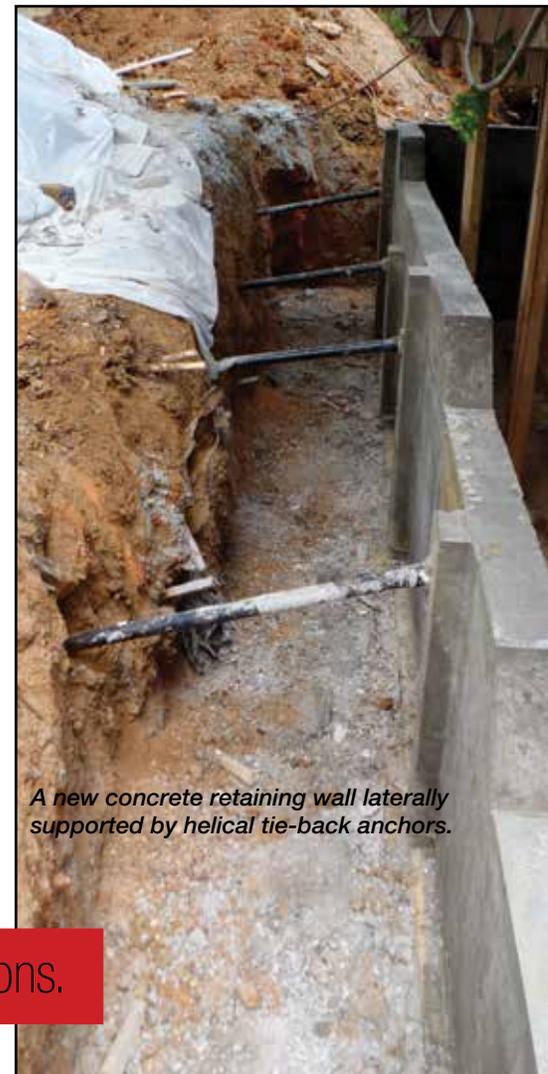
A new concrete retaining wall laterally supported by helical tie-back anchors.
