# 2014 CASE STUDY

Type: Residential | Issue: AL201404

## RECOVERY OF COMPLEX RETAINING WALL SYSTEM

85 Piles Stabilize  
a Hard-to-Access  
Hillside Pool  
and Patio

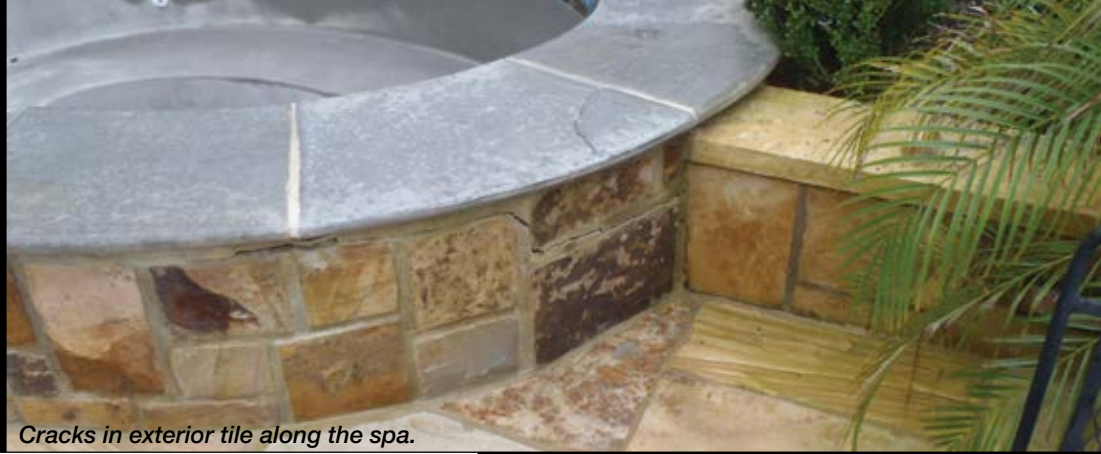
Cracks in exterior tile along the spa.

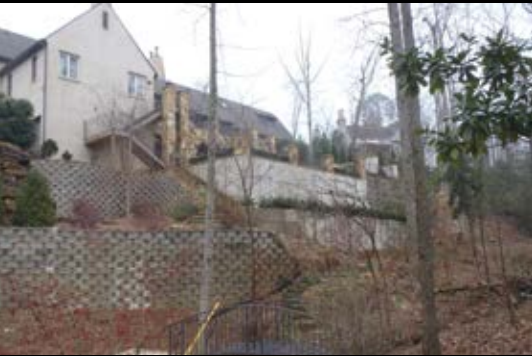
This picturesque, functional, and relatively new home in Birmingham, Alabama, boasts plenty of square footage, an oversized yard, and a beautiful pool; it has everything a family could ask for. However, lurking beneath the surface of what looks like a dream pool was a serious problem: a settling foundation. You might not notice it at first, but after close examination, you would find cracks in exterior tile, uneven ground, and other symptoms of foundation settlement.

Alabama Ram Jack proposed using a complex and delicately engineered system of helical piles to underpin the settling swimming pool, patio, and spa. The piles would not only provide vertical support, but they would also be reinforced with tie-back anchors to prevent horizontal movement and stabilize the leaning walls. Rather than try to repair the leaning segmental retaining walls, Ram Jack proposed the construction of a new poured-concrete retaining wall in front of the failing one. This would not only provide a cosmetic solution, but the wall would be

constructed on top of steel helical piles in order to ensure future settlement would not be a problem.

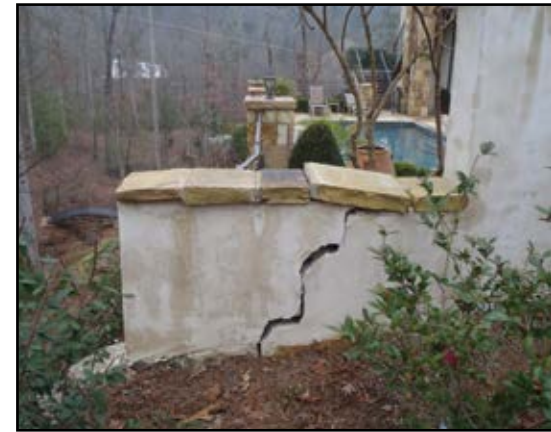
While the pool looks simple enough on the surface, it was built on an elaborate system of retaining walls behind the home. Within only one year of initial construction, everything began to go south, literally. The soil beneath the exterior pool and patio was not properly compacted, and the added weight of the new construction quickly created a settlement problem. The poured-concrete retaining wall around the pool was leaning forward and several segmental masonry retaining walls were also bulging. Complicating the situation, there was no vehicle access to the backyard where the repairs were needed.

ABOVE: the settling foundation led to cracks in the retaining walls

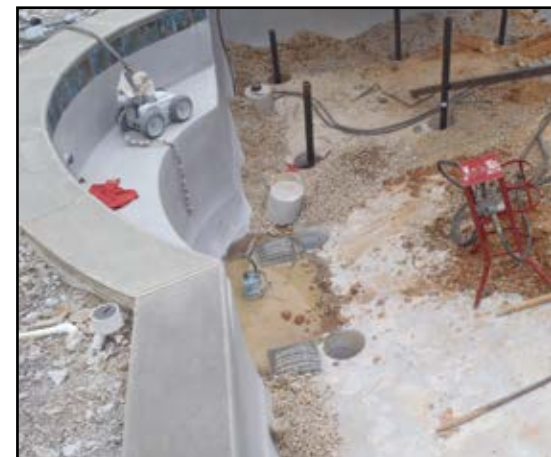
BELOW: underpinning the pool area

All of the installation equipment and helical piles were brought in without damaging any existing structures despite the lack of vehicular access to the backyard. All helical piles were installed as intended, and the new retaining wall was beautifully completed. In the end, 85 helical piles were installed to an average depth of 10 ft., lifting the pool and surrounding area 1.5 in. After the job was completed, the structural stability of the patio, pool, and spa are as strong as the area is beautiful.
