2015 CASE STUDY

Type: Residential | Issue: AL201506

**Helical Tie-Backs
Provide Maximum
Practical Recovery
to Home's Exposed
Footings**

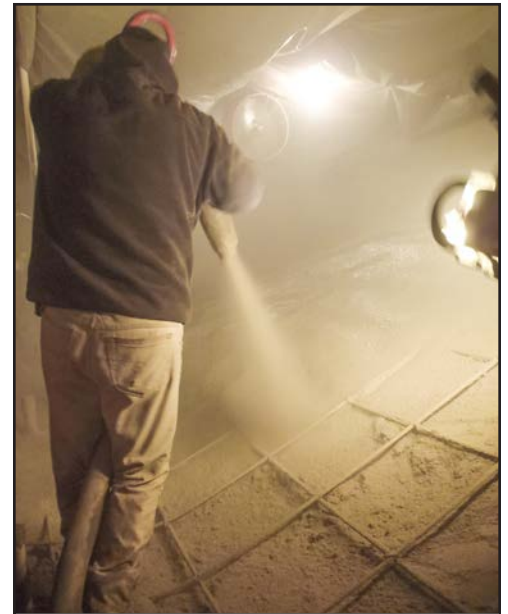
Shotcrete being sprayed after helical tie-backs were installed

Alabama Ram Jack proposed the installation of six helical piles in the crawl space to form a permanent support for the exposed footings. Additionally, Ram Jack advised that a retaining wall should be built to stabilize the soil bank under the house. In order to provide maximum support, the retaining wall would be comprised of steel helical tie-back anchors connected to a rebar grid within the shotcrete.

All plans were executed as proposed, permanently stabilizing the home and protecting it from further soil bank erosion and resultant foundation settlement. When finished, nine helical piles were installed to an average depth of 5 ft.

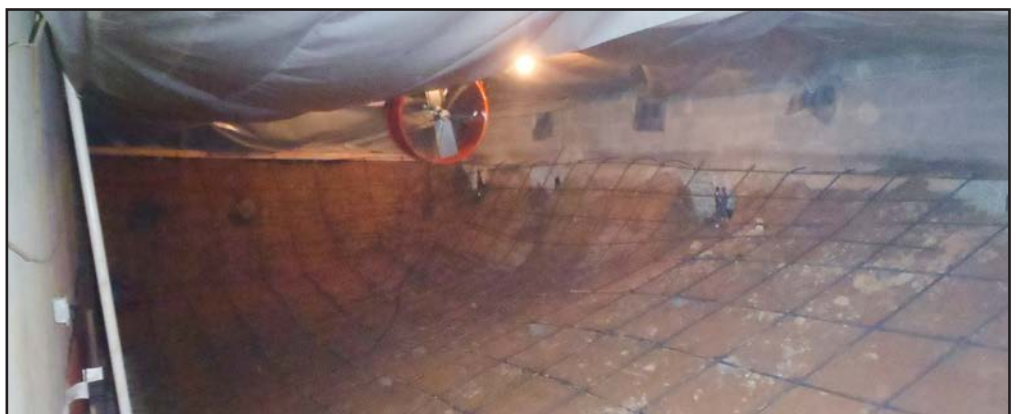
Helical tie-backs used in crawl space
