**RESIDENTIAL SWIMMING POOL
DECK REPAIR**
Talladega, Alabama

Helical Piles &
Folding Slab
Brackets

THE POOL IS OPEN!
Concrete Slab Pool Deck
Recovered to Original
Elevation, All While
Keeping the Pool in Service

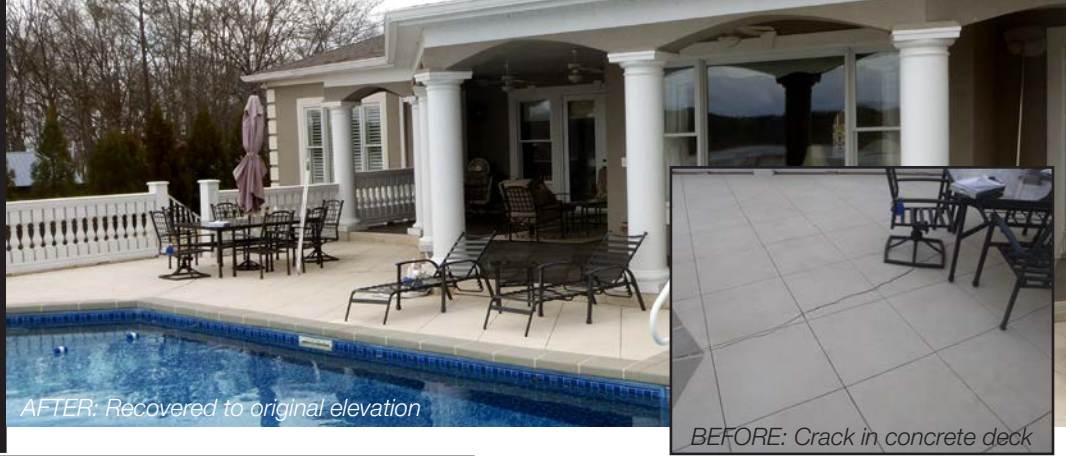
A homeowner in Talladega, Alabama, received estimates to repair his below-grade swimming pool's concrete-slab deck which cracked and settled nearly three inches causing water to pond.

Alabama Ram Jack installed six helical piles through 10" diameter holes cored through the pool deck and applied fold-out slab brackets. The helical piles were used to lift the pool deck for full elevation recovery.

disruption. The work was completed in two days, and the pool remained in service the entire time. Using quality materials and monitoring the installation torque/pressure ensured Ram Jack's ability to provide the owner with a lifetime guarantee against future downward movement.
