RAM JACK RESTORES A HOME

Bringing Together a
House After
Repeated Repair
Attempts Had Failed

Nebraska City, NE

REPAIR OF HOME ADDITION

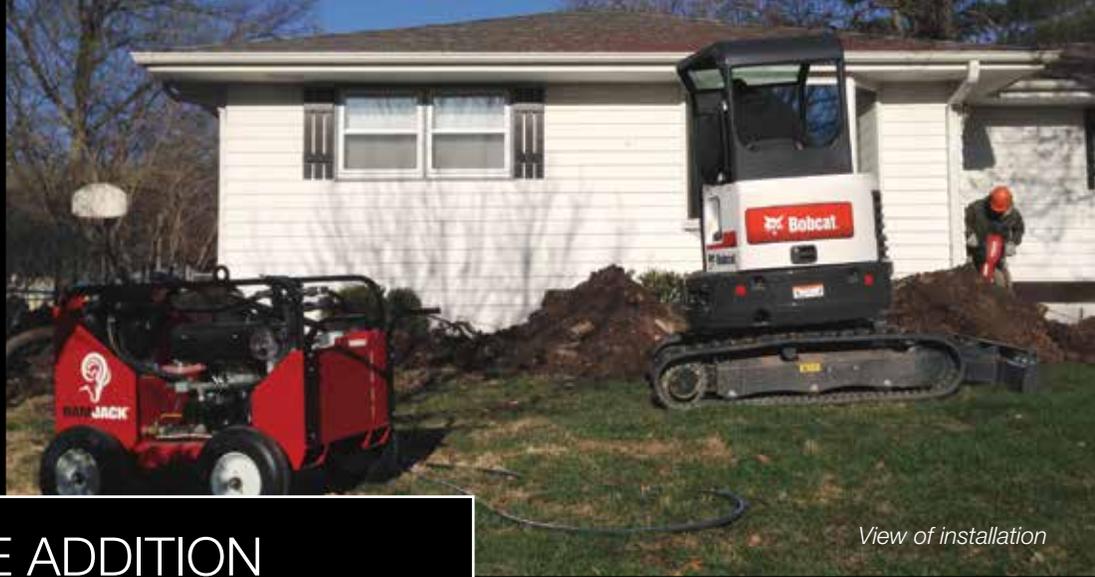
View of installation

Ram Jack Omaha proposed the installation of six helical piles with narrow-seat brackets and 4 ft. guide sleeves to lift and support the settling portion of the home. After installation, the settling areas of the addition would be lifted to maximum practical recovery to restore structural integrity.

Over the course of two days, Ram Jack Omaha completed the installation of the piles as proposed. There were no delays, and the piles

reached an average depth of 33 ft. The settling foundation was lifted more than 2 in., and the appearance of the charming Omaha home was restored. Upon completion of the project, the homeowner was completely satisfied with the work performed and was content knowing that the home she loved was safe and secure.

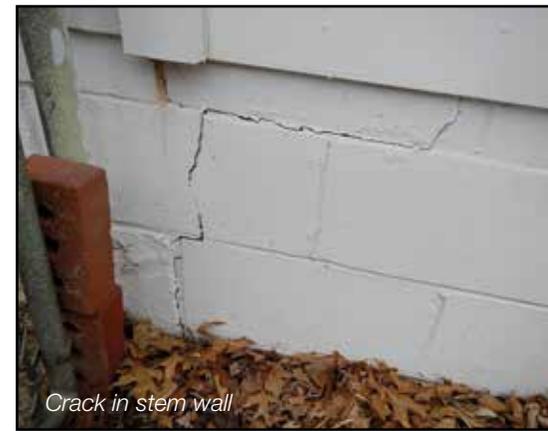
A 1970s construction with a full basement, the home's eight-foot addition was built in the early 1990s. The new section of the home didn't have a basement, and over the next 20 years it suffered from steady foundation settlement. Despite the fact that two repairs had already been done, which included adding concrete to the footing and an improperly installed helical pile, the addition continued to settle. Eventually, the damage grew too significant to ignore.

Crack in stem wall

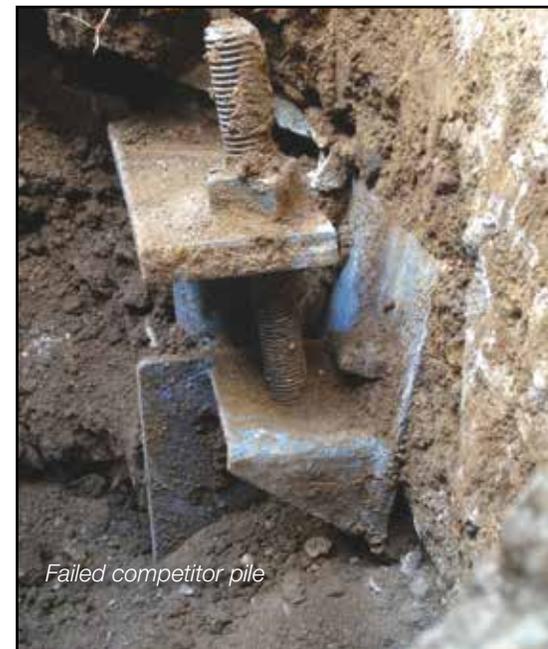
Failed competitor pile
