# 2004 CASE STUDY

## Business Uninterrupted as Ram Jack Puts Casino Back on Solid Foundation

# SLS HOTEL & CASINO | SETTLED SLAB RECOVERY

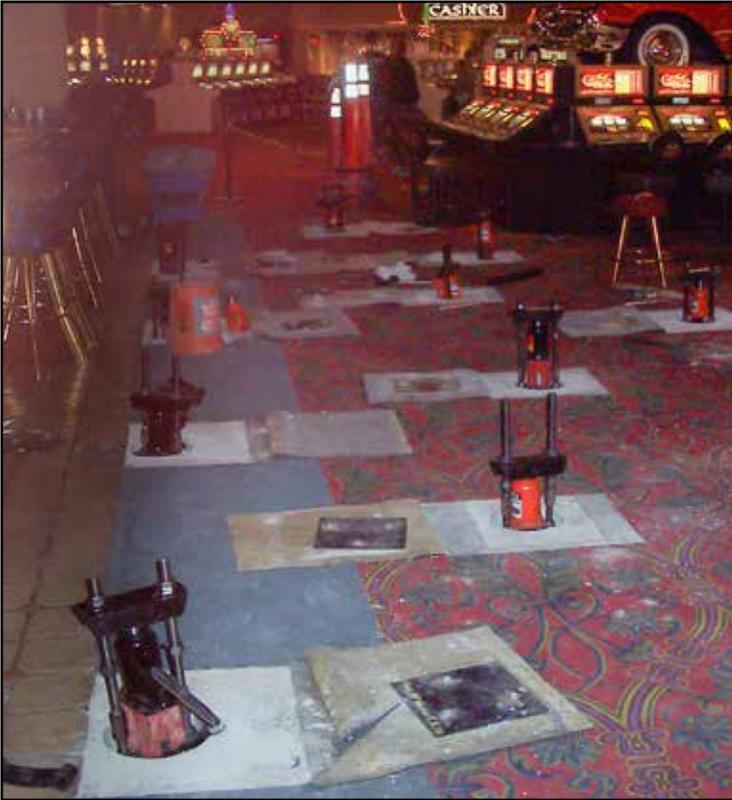
*15 Ram Jack Helical  
Piles Lift  
Up To 3 in. Of Slab  
Settlement*

Ram Jack Las Vegas worked with the casino's engineering team to provide a plan of action. After mapping out the channels in the slab to prevent damaging electrical conduits, Ram Jack Las Vegas proposed installing a grid of helical piles every 5 ft. in the affected area.

elevation. A Ram Jack retaining system was used to tighten and hold the slab in place. After the jacking system was removed from all holes, a line pump injected sand slurry under the slab to fill any voids, and all of the cored holes were filled. The engineers and maintenance workers at the SLS Hotel and Casino were more than impressed with the quality work performed by Ram Jack Las Vegas as well as the fact that the job was done with minimal interruption to casino business.

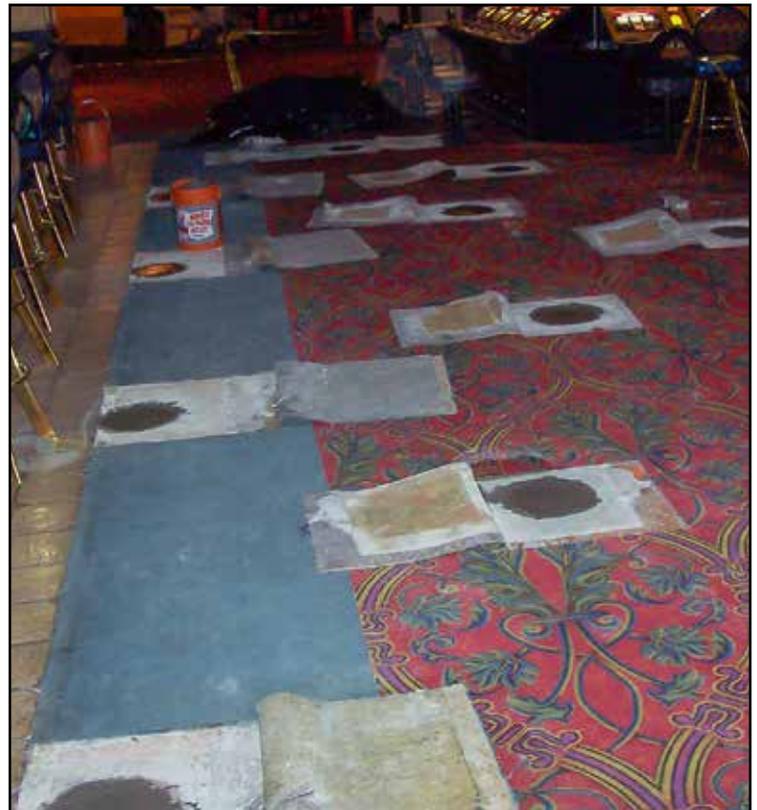
Because the work took place in an active area of the casino, Ram Jack Las Vegas professionals worked between 12 a.m. and 8 a.m. nightly until the job was complete. At the end of each “work day,” the job area was cleaned, all holes were covered, and the carpet was replaced so the casino could function without interruption. Ram Jack Las Vegas cored through the 6-7 in. slab at each of the 15 pile locations and installed each pile with a rotary torque head and extended resistance bar. Each pile was extended to the underlying Caliche hardpan about 10-14 ft. below grade. Once the piles were set, the support brackets were put into place and a jacking bracket brought the slab up to the original floor
