Ram Jack Location: Ram Jack Las Vegas | Las Vegas, NV | 877-452-2587

If a primary manifold at a water treatment plant for a large city fails or has to be shut down, it can mean significant water supply problems for a large population of people. Employees of the BNR Waste Water Treatment Plant, serving the City of Las Vegas, were facing such a crisis. After employing temporary measures to stop foundation settlement damage to a primary manifold, they contacted Ram Jack Las Vegas for a permanent solution.

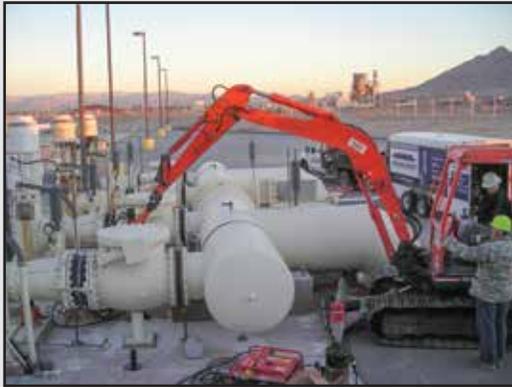
The primary manifold at the BNR influent pumping station in Las Vegas, part of the Water Pollution Control Facility, had settled several inches since its original construction. Associated with waste water being collected by the city sewer system, soil expansion and contraction likely exacerbated the problem, which was in need of rapid repair to prevent severe water treatment issues.

Working with HDR Engineering and the City of Las Vegas, Ram Jack Las Vegas professionals proposed the use of five W12x30 wide flange beams and nine helical piles to lift and support the foundation. Each of the nine helical piles would be installed through cored holes in the existing pavement under the manifold system. The primary beam would be supported by five helical piles and would support four perpendicular beams and four valves. The perpendicular beams would support the 42 in. diameter header pipe. The helical piles would be used to lift and stabilize the foundation for the primary manifold.

Because of the need to maintain the water treatment process during the repair, Ram Jack Las Vegas worked at night, allowing for slowing of the system if there was a leak or problem. An 11,000 lb. mini-excavator was used to work above and around the manifold. After coring the pavement, the 2 7/8 in. helical piles with beam brackets were installed according to plan, reaching an average depth of 35 ft. Jack hammers were needed to penetrate a tough layer of soil about five feet deep during helical pile installation. The beams were placed and support systems installed. When finished the foundation was lifted 2.5 in. for maximum practical recovery and to provide maximum support for the primary manifold. No leaks were noted at any joints or welds in the water system. The City of Las Vegas and HDR engineers were completely satisfied with the job performed and relieved the job was completed without damage to the water treatment system.
