Installer: Residential Foundation Solutions, LLC · Durham, NC · 888.309.9727

**SITUATION**

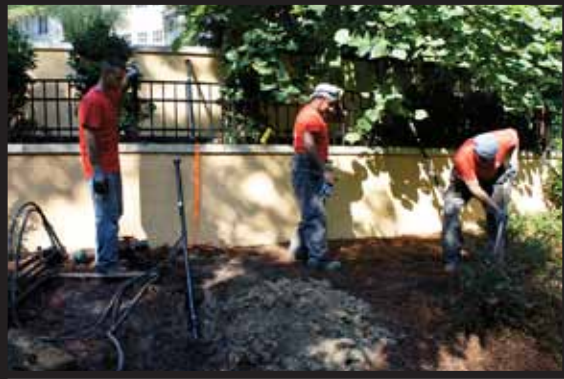
The home had a backyard pool that was beginning to slide away from the house and the double retaining wall surrounding the pool was cracked and bowing outward. During the evaluation, Ram Jack discovered that the home was constructed on subterranean rock formation. When the concrete pool was installed, it was backfilled with rock from previous demolitions. This creates voids underground making structures more susceptible to shifting and sinking.
