Type: Residential | Issue: SC201405

ROOT SYSTEM FOUNDATION DAMAGE

Ram Jack Installed
Three Driven
Piles for Complete
Recovery of Structure

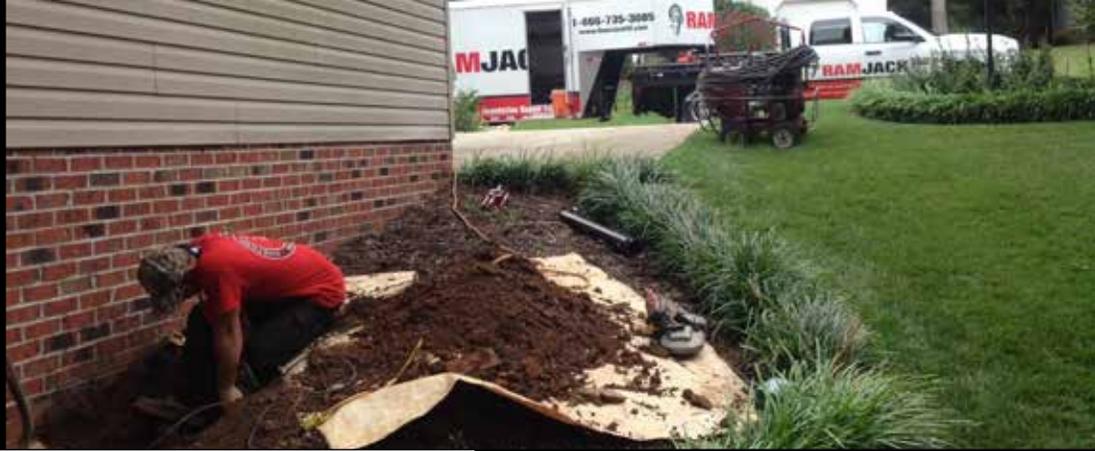
An inspection by a Ram Jack professional confirmed the homeowner's concerns, revealing the back, left corner of the home was falling away from the main structure due to underlying foundation settlement. A 1 in. crack that was nearly 2 ft. long followed the mortar line of the brick, and the problem had become so severe that some of the brick was nearly falling off of the exterior wall. In order to repair the falling walls, restore the integrity of the structure, and prevent further damage, additional foundation support would be needed as soon as possible.

stabilize the corner of the home and lift the sagging structure. Due to shallow footings, low profile brackets would be needed to prevent the repair materials from being visible after the repair was complete.

Ram Jack South Carolina's highly trained crew quickly got to work installing three driven exterior perimeter piles. However, before they were able to do so, they encountered an extensive root system in the area of installation. One particularly large root had even attached itself to the foundation of the home, wreaking havoc on the foundation and structure itself. In order to ensure that the repair was done properly and provided a permanent solution, the crew took its time in diligently removing the roots from the area. Eventually, they installed three piles to an average depth of 42 ft., lifting the foundation 1 in. for a complete recovery of the damaged structure and full closure of the cracks in the brick wall. The work was completed in only one day. After the work was done, the home was stabilized and the wall appeared nearly new, providing the homeowner with peace of mind, a lasting repair, and a cosmetically restored house. She was completely satisfied with the work, and she stated that she would recommend Ram Jack South Carolina to anyone in need of a foundation repair.
