# 2014 CASE STUDY

Type: Residential | Issue: SC201407

## HOME WITH FAILING WALL RESCUED BY RAM JACK

Irmo, South Carolina

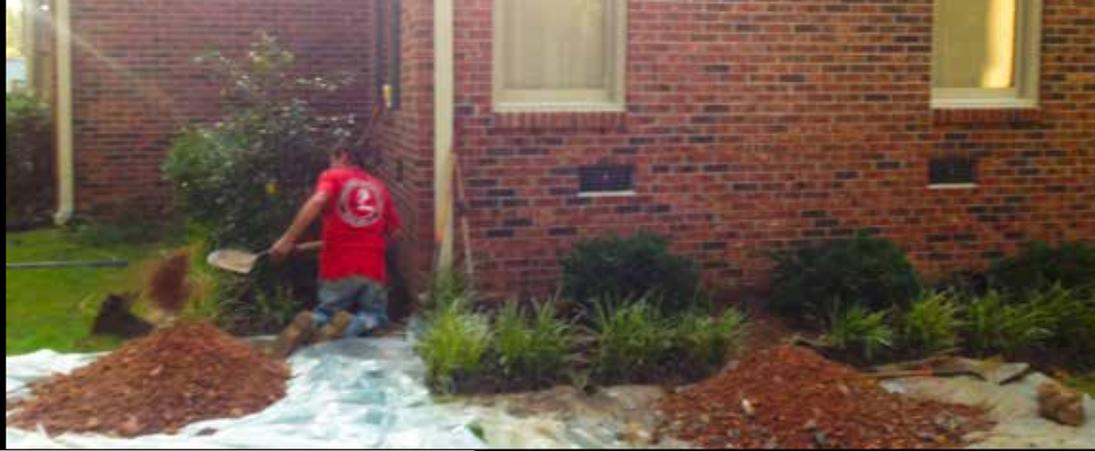
## VERTICAL CRACK IN BRICK

A vertical crack formed in the brick on the right side of Julius's home's facade. Desiring to take care of the problem before it could get any worse, he contacted Ram Jack South Carolina for an inspection and estimate. The Ram Jack professional inspector confirmed the homeowner's findings, locating a 7 ft. vertical crack that began at the soldier brick under the window and extended all the way to the ground. Complicating the issue, the crack crossed through an opening in the brick (lintel) before continuing into the 7 in. thick concrete footer. The residential structure was the victim of foundation settlement resulting in failing walls, which threatened the integrity of the building in addition to flawing its appearance.

After completing a thorough inspection, Ram Jack proposed the installation of three piles. One would be placed at the corner of the building while the other two would be placed on each side of the crack with a goal of lifting the wall to restore its structural strength.

Ram Jack South Carolina installed three 2 7/8 in. driven piles on the front right corner of the building with a 9 in. footer. The first pile was placed under the side wall, and the other two piles were placed in the front of the home. Each of the piles reached a depth of 21 ft. A 0.75 in. lift was achieved, lifting the settling of the corner of the building and closing the cracks for a more pleasing appearance.
