VOID BELOW FOUNDATION CAUSES SETTLING

Driven Piles Stabilize
Compromised
Areas of Structure

LOUIS RICH TURKEY PROCESSING PLANT

Newberry, South Carolina

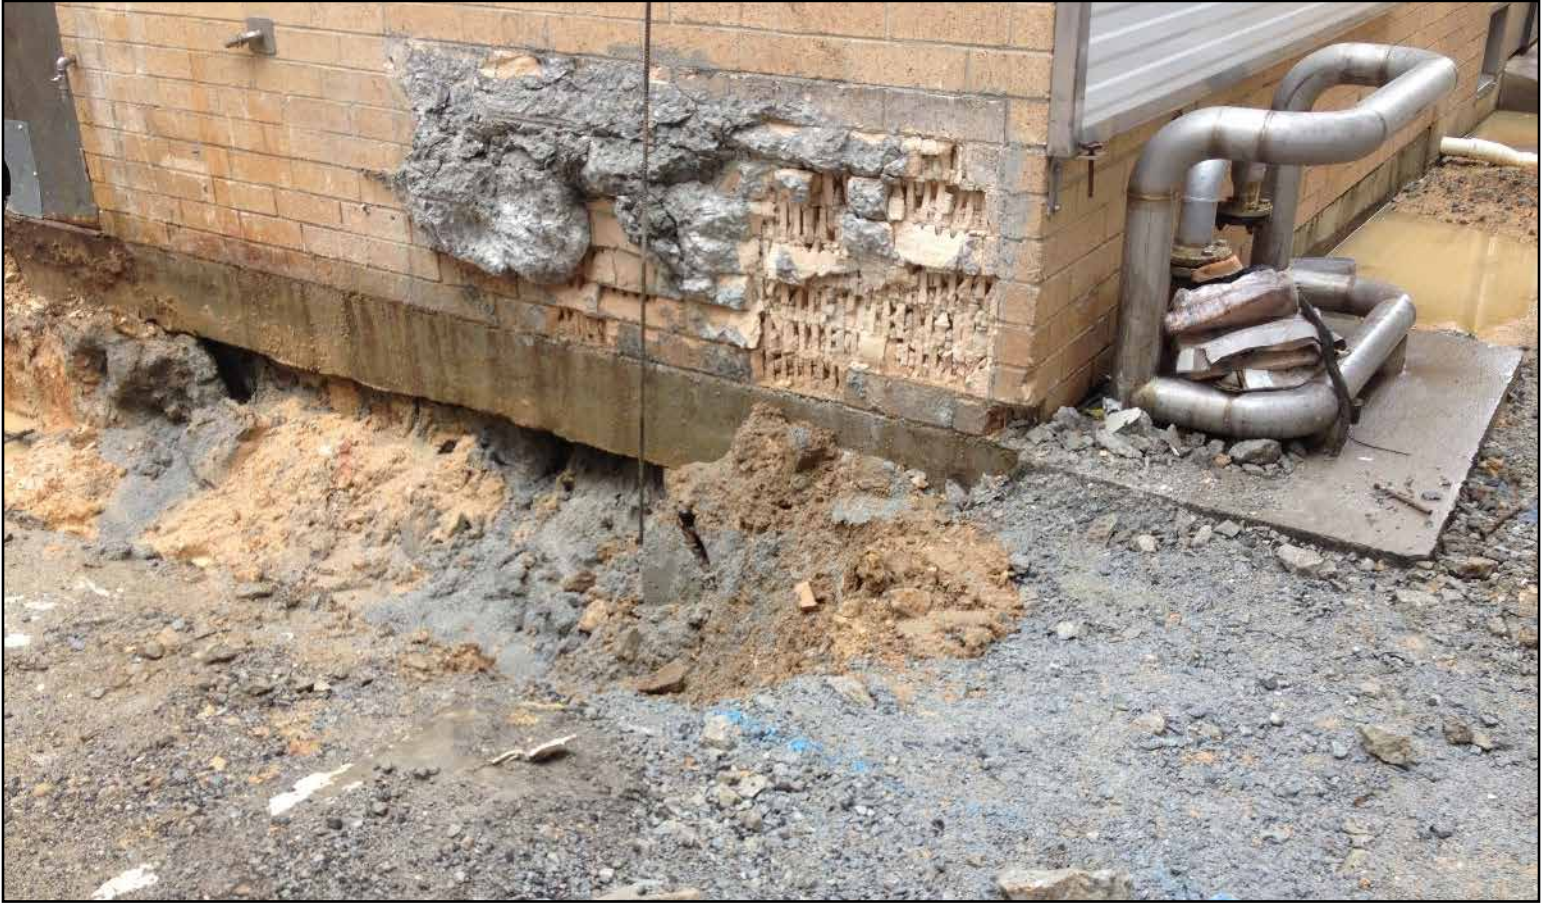
An inspection of the commercial structure revealed a 12 ft. portion of the building was settling due to a lack of adequate support for the foundation. A significant void beneath the foundation was evident. While the structure had yet to experience significant settlement, it undoubtedly needed increased support to bolster the foundation and prevent subsequent damage.

Ram Jack proposed the use of three driven piles to provide additional support to the existing foundation and to stabilize the compromised area of the building. Each pile would be strategically placed in a 7 ft. section to provide maximum stability and support to the structure. After reviewing the proposal with the plant owner, Ram Jack was given the green light to get to work.

Three driven piles were installed to an average depth of 18 ft., providing maximum practical recovery for the building by stabilizing the compromised area. No lift was achieved as none was required in the stabilization-only operation.

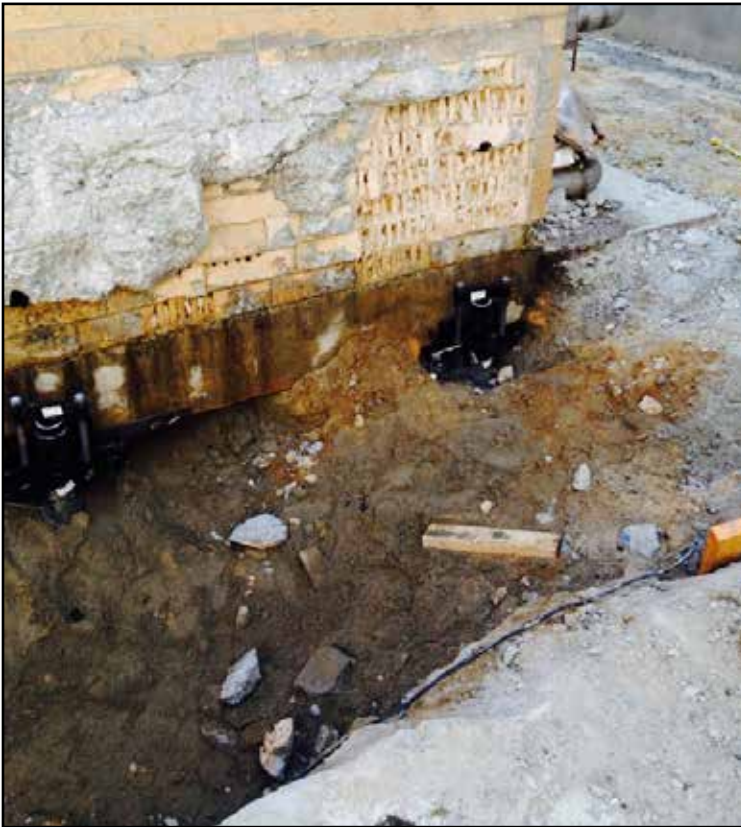
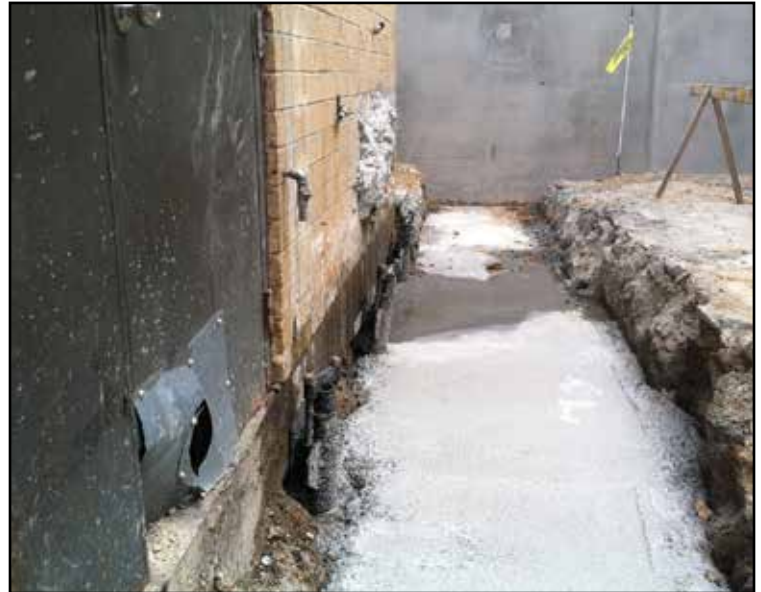
During installation of the piles, the Ram Jack crew ran into a number of issues, having to make their way around concrete as well as drive one of the piles to a depth of 35 ft. After some significant excavation and diligent work by the crew, the driven piles were successfully installed, and the building's structural integrity was restored.
