2014 CASE STUDY

Type: Residential | Issue: SC201414

RAM JACK DRIVES IT HOME

Driven Piles and
Angle Iron Restore the
Failing Foundation of a
Front Patio

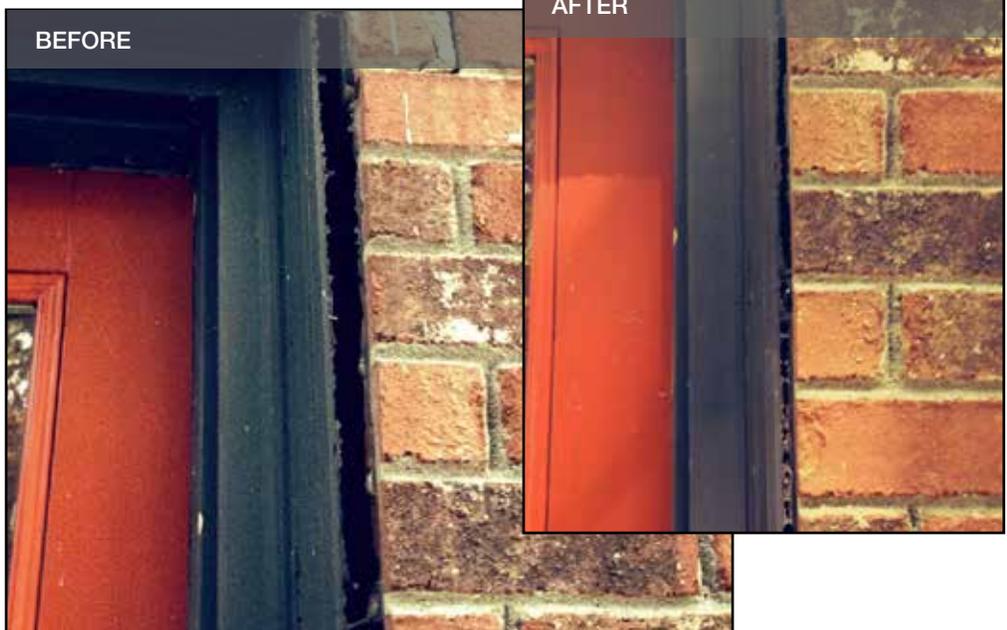
*The sagging wall
was lifted to achieve
maximum practical
recovery.*

The crew removed deck boards atop the front patio in order to properly install the piles. In addition, it was necessary to add angle iron to support the failing footers beneath the deck. After placing the angle iron and installing three driven piles to an average depth of 39 ft., the sagging wall was lifted to achieve maximum practical recovery, and the separation between the door and wall was significantly reduced. After all of the hard work, the cosmetic appearance of the home was improved and its structural stability was ensured, putting the customer's mind at ease.
