# 2015 CASE STUDY

Type: Residential | Issue: SC201505

Ram Jack Helical  
Piles Stabilize Hilton  
Head Home Built on  
Poor Soil

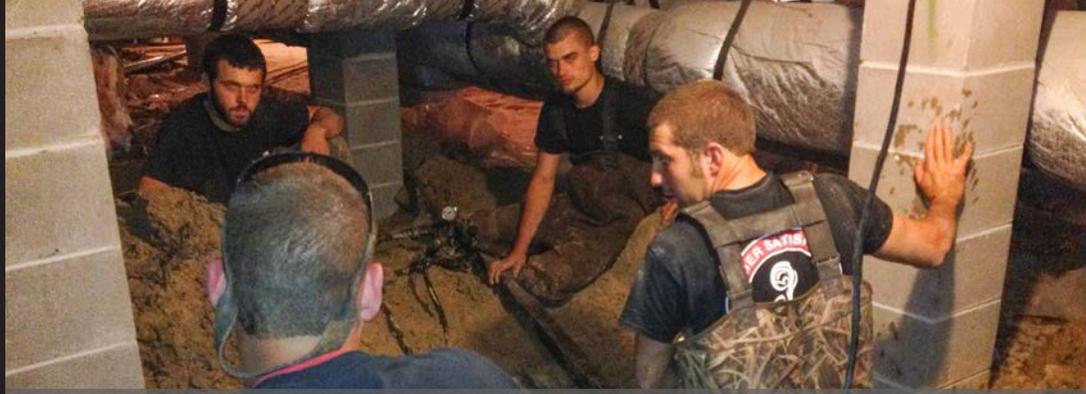
Crew installs helical piles in crawl space

Working with Applied Building Sciences Inc., an architectural engineering company located in Charleston, SC, Ram Jack South Carolina proposed using helical piles to permanently lift and stabilize the home to its original position. The structure was strategically mapped out based on geography and the severity of settlement, and helical piles were assigned positions as needed.

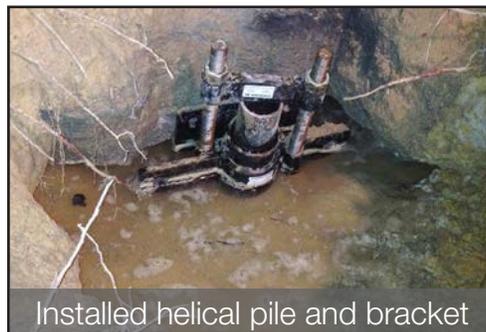
Installed helical pile and bracket

After encountering some obstacles and coordinating with Applied Building Sciences, the original plan was adjusted, as it was discovered during demolition that the underlying foundation did not match what was expected. With a foundation deeper than expected, and the nearby pool and deck, continuing with the original plan would have been incredibly expensive, so that plan was scrapped for a more prudent one. All in all, 31 helical piles were used to underpin the existing interior, 42 helical piles were installed to support the existing perimeter footing, and five helical piles were used to bolster portions of the exterior walls. The structure was stabilized; no lift was attempted, as it was not feasible or practical. Working underneath the entire structure in damp, close conditions, Ram Jack South Carolina completed the repair in just four days.
