## CASE STUDY

Type: Residential | Issue: SC201507

### Near-Complete Recovery Achieved on Home with Severe Foundation Damage

15 Multi-Helix Piles Stabilized Structure

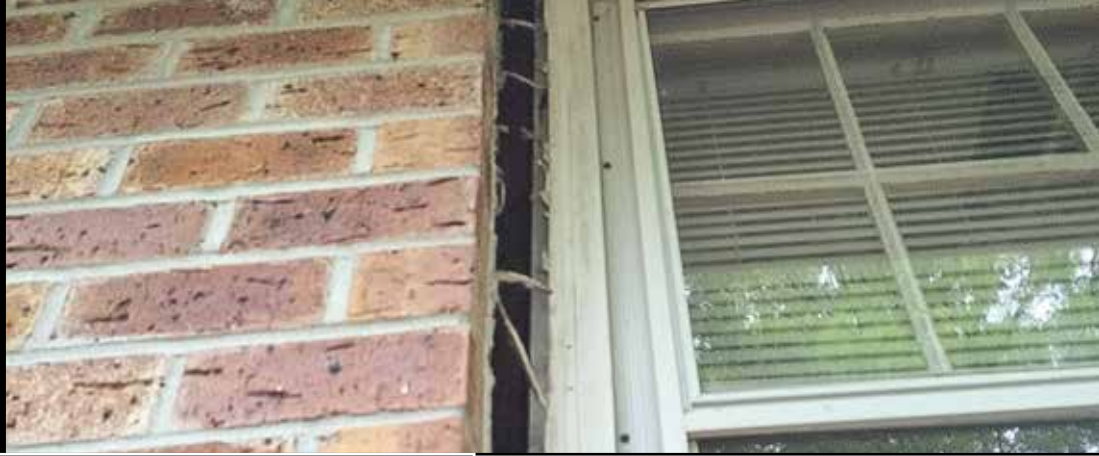
## SEVERE FOUNDATION SETTLEMENT

BEFORE: Severe foundation settlement caused 2-inch cracks in the brick

AFTER: Recovery of foundation and closure of bricks

Jim Green, P.E. of Ram Jack South Carolina came up with a design plan to install 15 multi-helix piles, strategically placing them in the ground beneath three sinking corners of the home to lift and stabilize the structure. While the level of settlement of the home was so severe that it was unknown how much Ram Jack would be able to lift the structure, the helical piles would, at a minimum, stabilize the

structure in place. Stiff knees would also be used to push the brick back together throughout the process to close the large cracks in the brick.

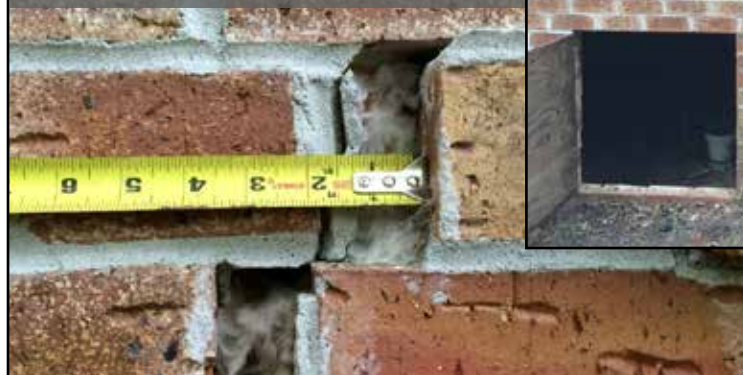
The residence had all of the traditional markers of a failing foundation. Various windows and doors throughout the home were difficult to open and close or wouldn't do so at all. Large cracks were forming in the mortar, causing the bricks to separate from one another as much as 2 in. The brick walls were separating from numerous window and door frames. All in all, three out of the four corners of the home needed foundation repair.

Over the course of two days, 15 helical piles were installed according to the engineer's design, torqued to an average depth of 16 ft. The structure was lifted as much as 4 in. Four stiff knees were used to effectively move the brick back together. When the job was finished, the home was stabilized, most of the walls had been lifted back to achieve complete recovery, and the walls that weren't full recovered only deviated a minor 0.1 in. When finished, the homeowners were ecstatic, saying, "The work was excellent - absolutely beautiful work. The crew was very informative and nobody could have ever convinced me that the bricks would have such great recovery; you can hardly tell there were existing cracks."
