2005 CASE STUDY

**Multi-Unit
Apartment
Facility Settles
on Weak Canyon
Fill Soils**

LA VERKIN APARTMENTS | STRUCTURE STABILIZATION

La Verkin, UT

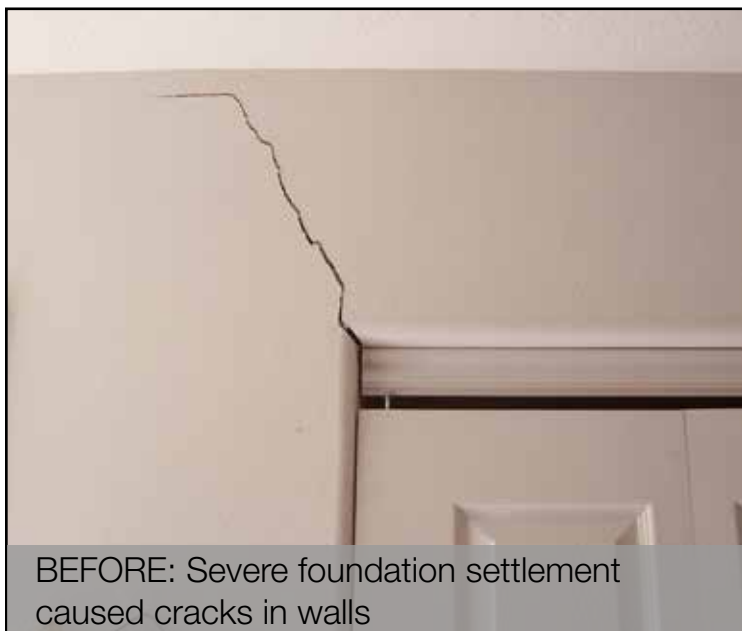
SITUATION

BEFORE: Severe foundation settlement caused cracks in walls

Over the course of two days, Ram Jack Utah installed nine 2 7/8 in. driven piles to a design load of 24.5 kips. The piles and standard brackets reached an average depth of 37 ft., lifting the structure as much as 4.5 in. for complete restoration of the structure to its original position. The depth of each pile varied along with the original canyon bottom below and were extended to a suitable load bearing strata. After raising the slab, the void created was filled using the slab jack method, in which a specialized material is force-injected under the slab lifting it back to its original placement. After Ram Jack was finished, the owner was impressed with the work. The owner expressed excitement seeing that the large cracks throughout the building had closed. He was also very pleased to find that the doors and windows now operated smoothly.

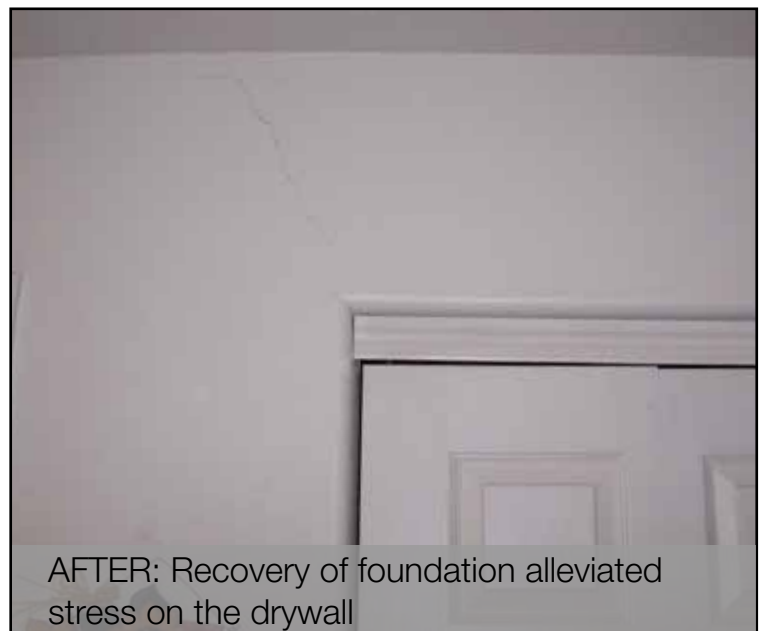
AFTER: Recovery of foundation alleviated stress on the drywall

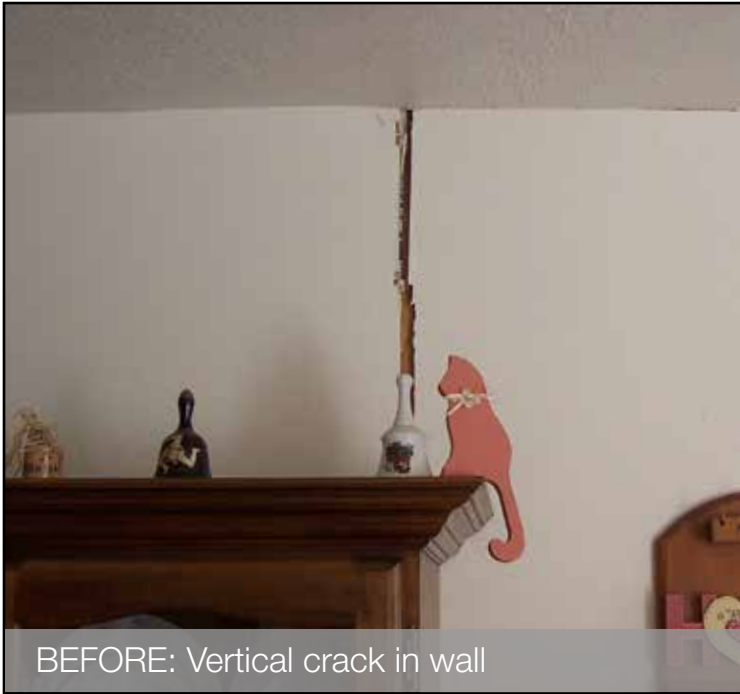
BEFORE: Vertical crack in wall

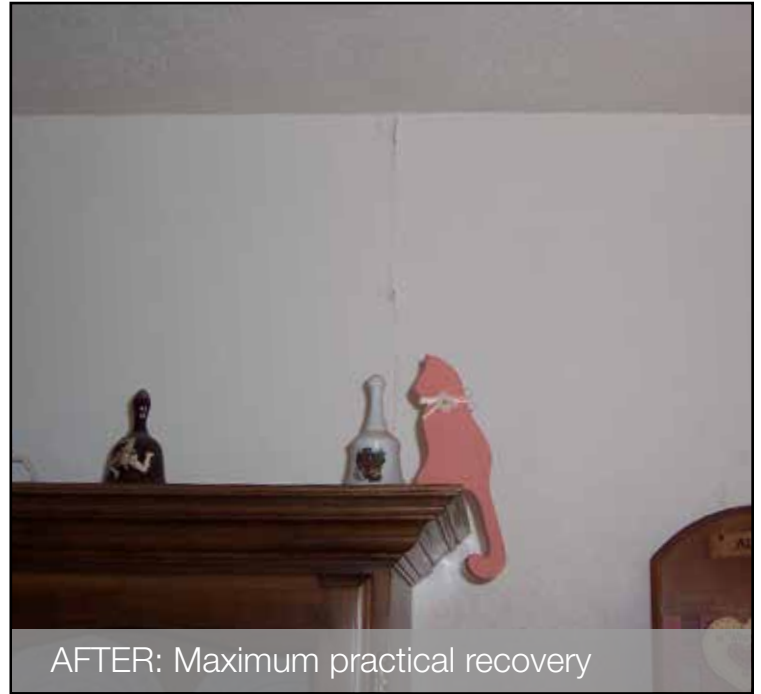
AFTER: Maximum practical recovery
