# 2014 CASE STUDY

Volume: 2014 | Issue: Concrete Pier Failure

90+ Piles Required  
to Secure Home  
From Further  
Damage on Hillside

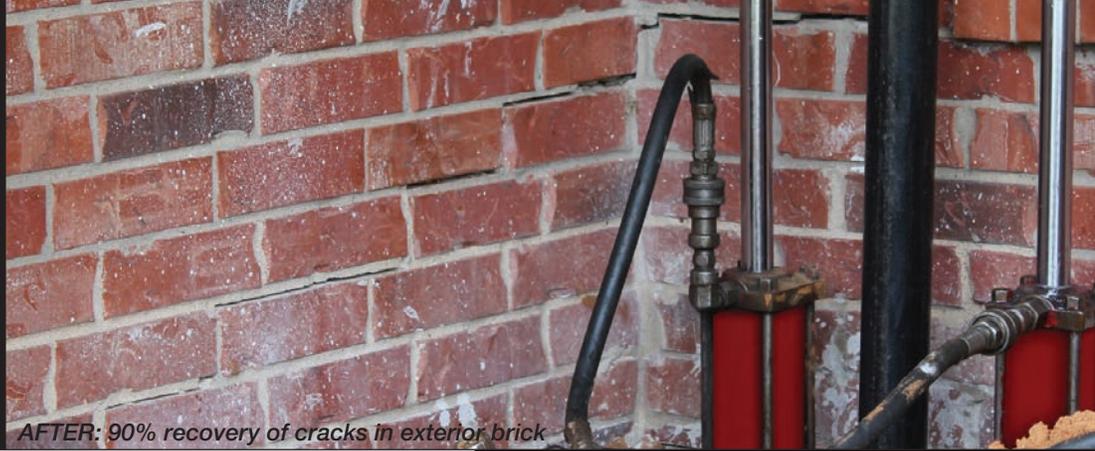
*AFTER: 90% recovery of cracks in exterior brick*

The Ram Jack foundation system went more than 30’ deep, a stark contrast to the 10’ depth reached in the preventative concrete pilings. By the end of the project, 10” of lift and more than a 90% recovery was achieved, allowing the family to return to their home and have peace of mind that the problems wouldn’t return.

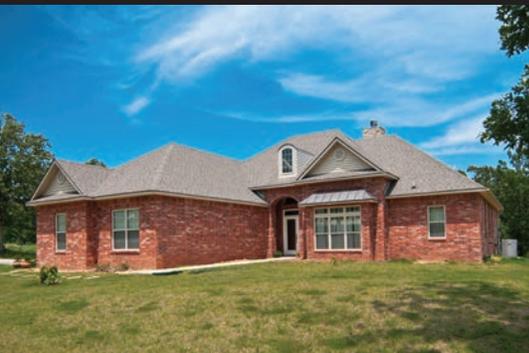
*BEFORE: (left) crack in exterior brick; (right) interior sheet rock crack*

home to have experienced structural damage due to foundation settlement—over 11” in some areas. The entire perimeter of the home needed to be stabilized by driven steel piling, and the interior slab needed helical slab stabilization. Before installation could occur, all existing concrete piers had to be disconnected from the structure, then 60 interior helical piles and 39 exterior driven steel piles could be installed to a proper load-bearing strata to support the home for the lifetime of the structure.
