2014 CASE STUDY

Volume: 2014 | Issue: Concrete Pier Failure

RAM JACK TO THE RESCUE

90+ Piles Required
to Secure Home
From Further
Damage on Hillside

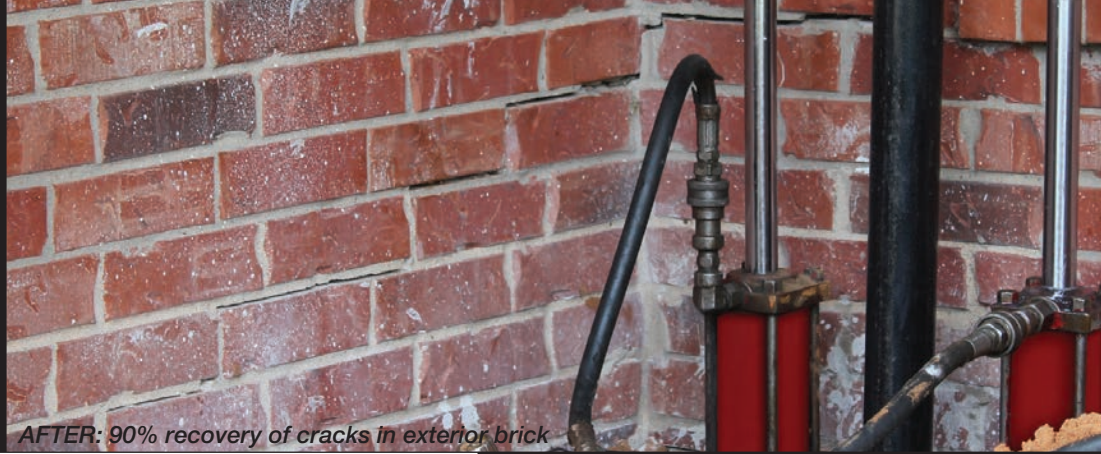
AFTER: 90% recovery of cracks in exterior brick

The Ram Jack foundation system went more than 30’ deep, a stark contrast to the 10’ depth reached in the preventative concrete pilings. By the end of the project, 10” of lift and more than a 90% recovery was achieved, allowing the family to return to their home and have peace of mind that the problems wouldn’t return.

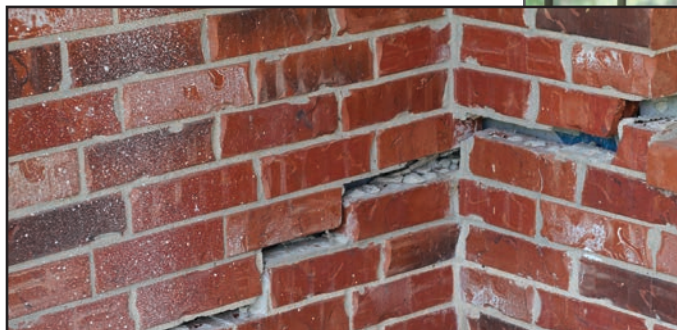
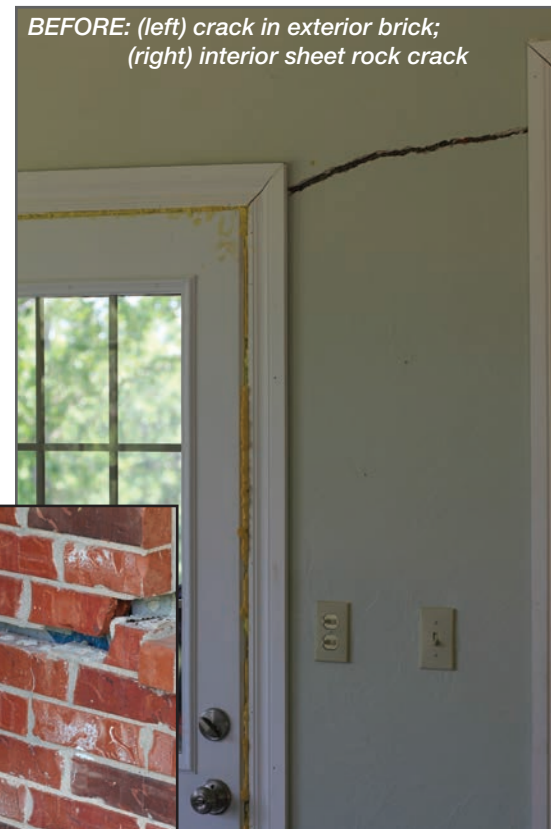
home to have experienced structural damage due to foundation settlement—over 11” in some areas. The entire perimeter of the home needed to be stabilized by driven steel piling, and the interior slab needed helical slab stabilization. Before installation could occur, all existing concrete piers had to be disconnected from the structure, then 60 interior helical piles and 39 exterior driven steel piles could be installed to a proper load-bearing strata to support the home for the lifetime of the structure.

BEFORE: (left) crack in exterior brick; (right) interior sheet rock crack
