# 2015 CASE STUDY

Type: Residential | Issue: AL201502

**Helical Piles Provide  
Cost-Effective  
Recovery of Deck  
in Soft Soil**

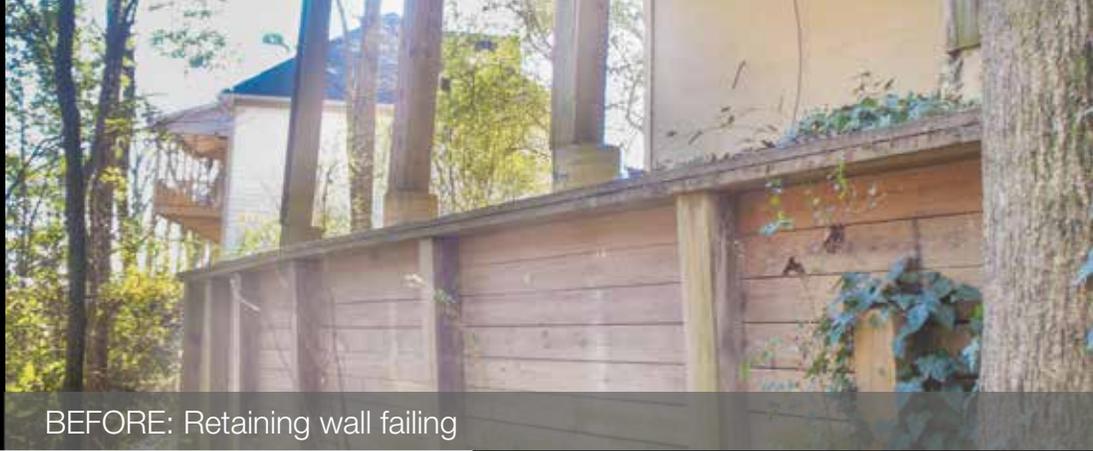
BEFORE: Retaining wall failing

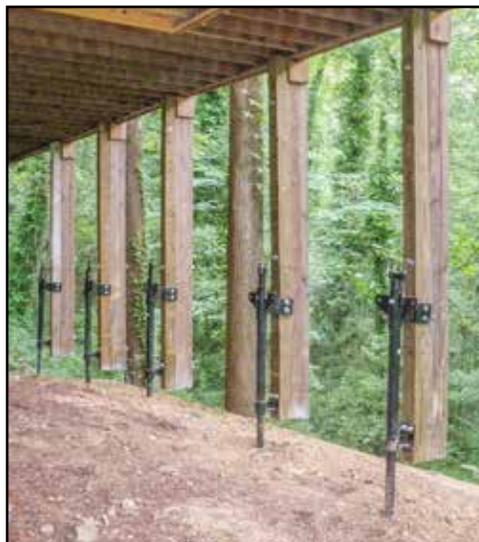
AFTER: Steel piles replaced concrete footings

Alabama Ram Jack successfully installed the steel frames and six helical piles to an average depth of 10 ft. One interior helical pile and bracket was installed to replace an interior concrete footing. The structure was lifted 2.5 in. for complete recovery. The deck structure now has a permanent support system that will remain stable even if the retaining wall continues to settle, and the members of the household have the perfect place to enjoy the beautiful environment in which the home resides.

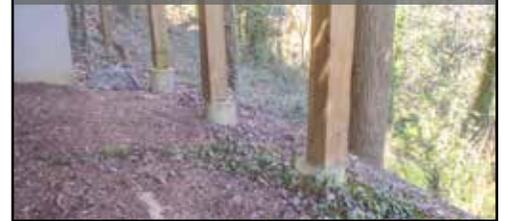
BEFORE: Concrete footings settled as retaining wall failed
