# 2015 CASE STUDY

Type: Residential | Issue: AL201507

## Effects of Failed Concrete Pilings

Previous Inferior Concrete Repair  
Failed, Causing Continued Damage

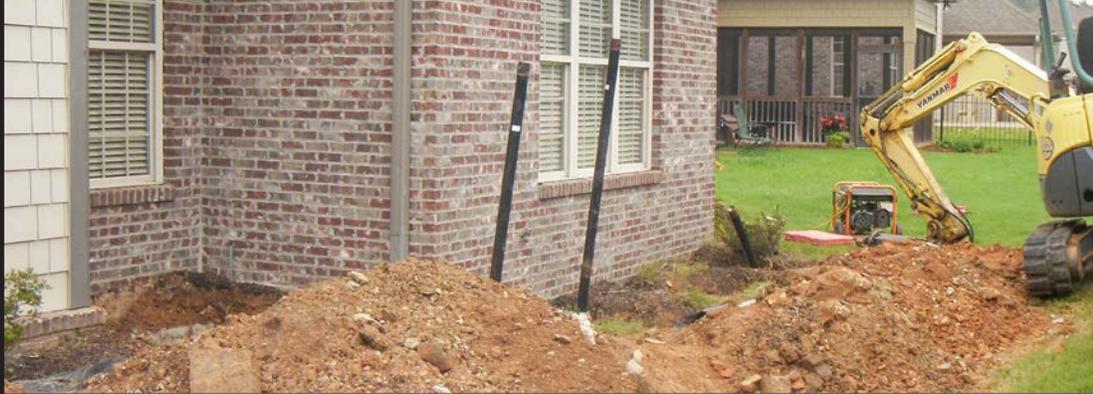
Ram Jack steel piles used to replace previous company's failed repairs

Alabama Ram Jack encountered rocky conditions, so five helical piles and 13 driven piles were installed, lifting the foundation 1 in. for maximum practical recovery. The steel piles provided a permanent solution to the recurring foundation problem, and the repair cost was about the same as the previously implemented inferior repair that failed.

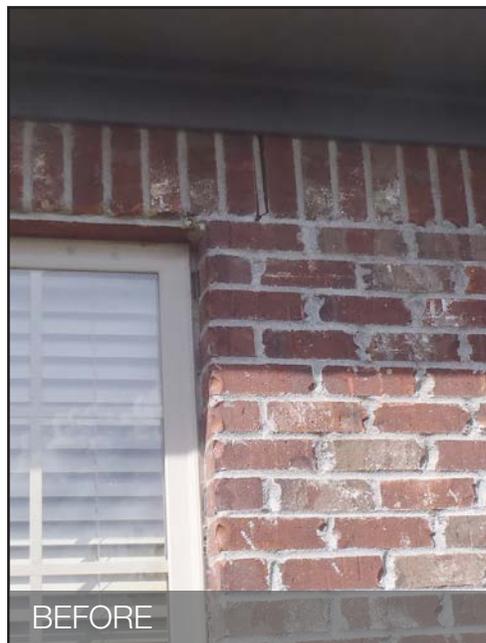
BEFORE

The customer previously hired a local engineer to evaluate the issue, who recommended increasing the footing depth by placing more concrete under the existing footings. The owner followed the engineer's recommendations despite the substantial cost associated with the proposed repair; however, it did not provide a permanent solution. Settlement continued, and new cracks formed in the brick.

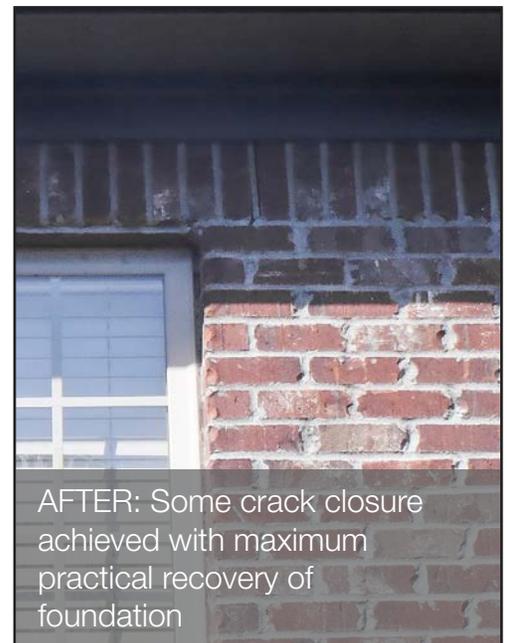
AFTER: Some crack closure achieved with maximum practical recovery of foundation
