# 2016 CASE STUDY

Type: Residential | Issue: OR201601

**Settled Home  
Strategically Raised  
to Full Recovery**

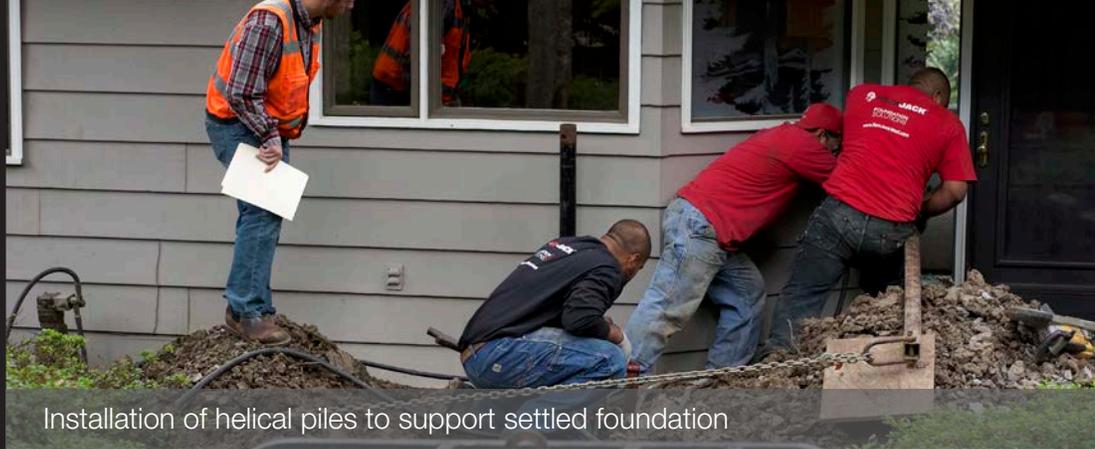
Installation of helical piles to support settled foundation

Working with Regal Mortier, a local engineering firm, and after careful consideration, Ram Jack proposed installing 13 helical piles on the exterior perimeter of the home. The piles would be strategically placed on the north, west, and east sides of the home for the best chance of achieving maximum recovery.

During the installation Ram Jack needed to remove part of the deck in the homeowner's backyard to get access for pile installation. At the front of the house Ram Jack had to break and haul approximately a half yard of concrete to access the pile location. The 13 piles were installed successfully. The house was raised 3/4 in. to achieve a complete recovery. The job took 10 work days to complete. The homeowners were happy with the outcome of the job.

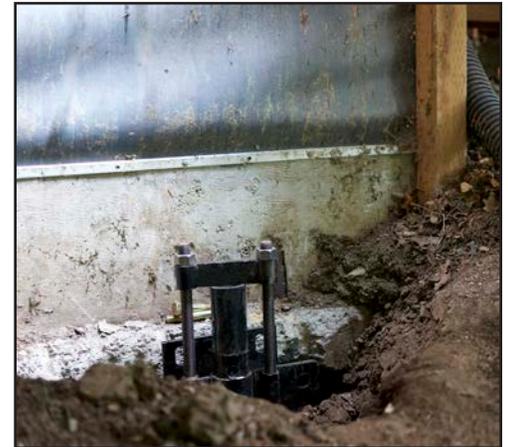
The homeowner started to notice warning signs of foundation failure around the home. The floors started to slant. Cracks formed in the exterior of the foundation of the northeast corner of the home.

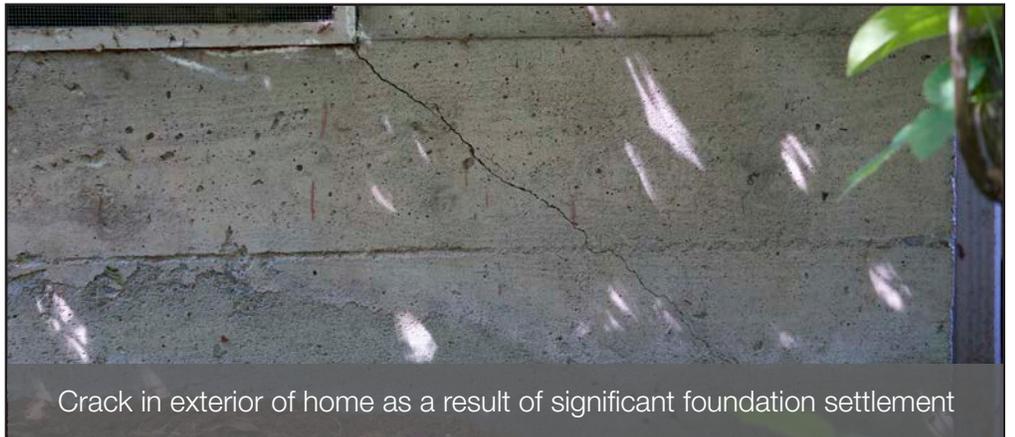
Crack in exterior of home as a result of significant foundation settlement
