# CASE STUDY

Ram Jack Steel Piles Stabilize Building After Adjacen
Retaining Wall Fails

## Ram Jack Supports Apartment Building on the Edge

Marshall Township, Pennsylvania

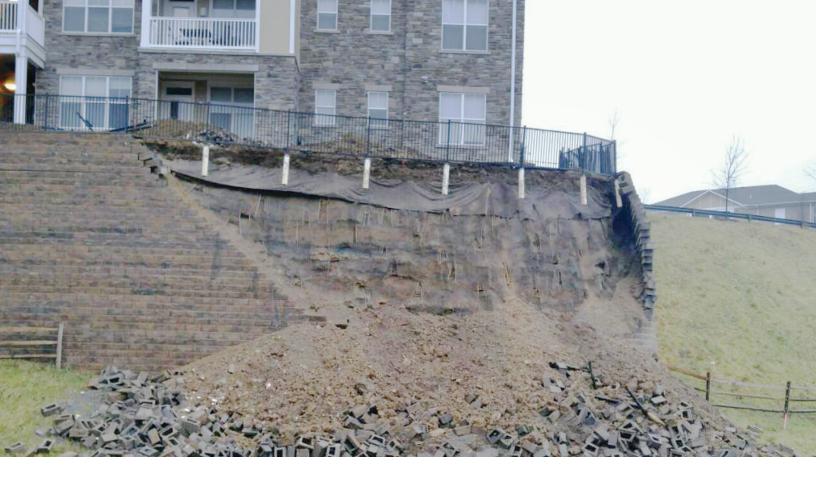
A four-story multi-unit housing building within a larger apartment complex sits adjacent to a 30-ft. segmented retaining wall. This location provided nice views for the tenants, but big problems lurked beneath the structure. The building settled 8-12 in. As photos from August 2016 show, large shear cracks were observed in the soil adjacent to the building as well as in the foundation (up to 7 in. in the soil and 1 ½ in. in the foundation). The segmented retaining wall also showed large cracks.

Photos taken one month later showed the extreme growth of cracks.

Ram Jack engineers advised the property managers and engineers of record that the retaining wall would likely fail, and action needed to be taken to secure the structure. Thankfully, Ram Jack Ohio was contracted to begin underpinning in December 2016. When work began, excessive water observed beneath the foundation tested positive for chlorine, and plumbing checks revealed a multitude of leaks beneath the building.
