2014 CASE STUDY

STRUCTURAL INTEGRITY RESTORED

Irmo, South Carolina

Six Driven Piles
Recover Foundation
Damaged by Soil
Changes

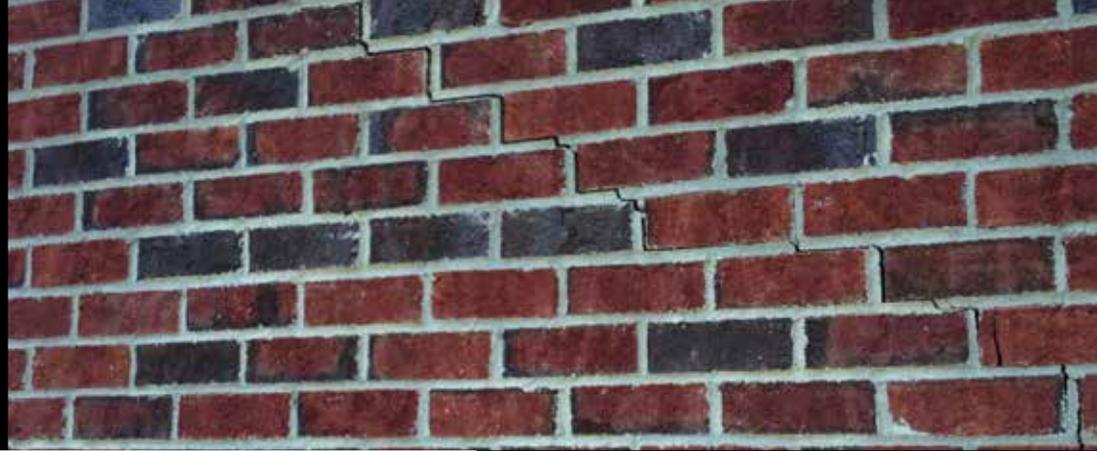
MOISTURE DAMAGED FOUNDATION

When the homeowner noticed a growing crack in her home's brick exterior wall, she called Ram Jack South Carolina. A Ram Jack inspection of the single-story, brick veneer home revealed a 7 in. stair-step crack in the rear, right corner of the structure running from the soldier brick at the bottom of a window down through the footer. In addition, a corresponding 1 in. drop of the structure in the area was noted. The cause of the failing wall appeared to be foundation settlement associated with soil expansion and contraction.

A team of professionally trained, experienced Ram Jack crew members installed six (6) 2 7/8" piles with standard brackets in strategic locations around the failing wall. The piles reached an average depth of 42 ft., and an average lift of 3/4 in. was achieved. The crack closed up nicely, and the failing wall's structural integrity was restored. The homeowner was extremely pleased with the work performed by Ram Jack South Carolina and eagerly signed off after a final inspection.
