Type: Residential | Issue: SC201412

HOME SWEET HOME

Four Piles Restore
Structural Stability
to a Front Porch

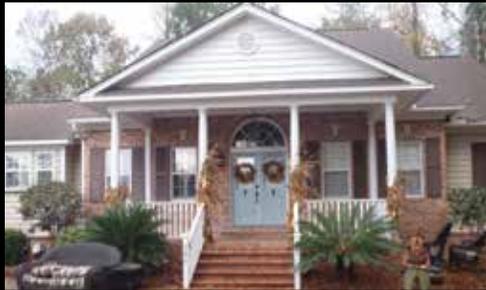
FRONT PORCH SEPARATION

A homeowner in Goose Creek, South Carolina, noticed a crack forming near her home's front door; she was anxious to get it taken care of as soon as possible. She contacted Ram Jack for the inspection and repair. A thorough inspection of the property confirmed the initial complaint. Just adjacent to the home's front door on the left side of the front steps was a large crack in the mortar of the brick wall. A similar fracture in the mortar was also found in the bricks on the right side of the front steps. Additionally, the entire front porch appeared to be separating from the main structure, as evidenced by a crack along the entire length of the brick where it meets the porch.

The Ram Jack South Carolina inspector proposed the installation of four helical piles. Tiles would be removed from the front porch, and the helical piles would be strategically located to lift the front porch back into place and restore the structural integrity of the porch and walls. The front porch would then be re-tiled, concealing the newly installed helical piles.

Four (4) 2 3/8 in. diameter helical piles with slab brackets were installed as proposed. The piles reached an average depth of 10 ft. and lifted the front porch and damaged wall 1/2 in. for a complete

recovery from the foundation settlement damage. Additionally, the fractures and cracks in the brick were closed, restoring the home's beauty along with its structural integrity.
