2015 CASE STUDY

Type: Residential | Issue: SC201506

**Helical Piles
Recover Porch
Slab Sinking
Due to Poorly
Compacted
Soil**

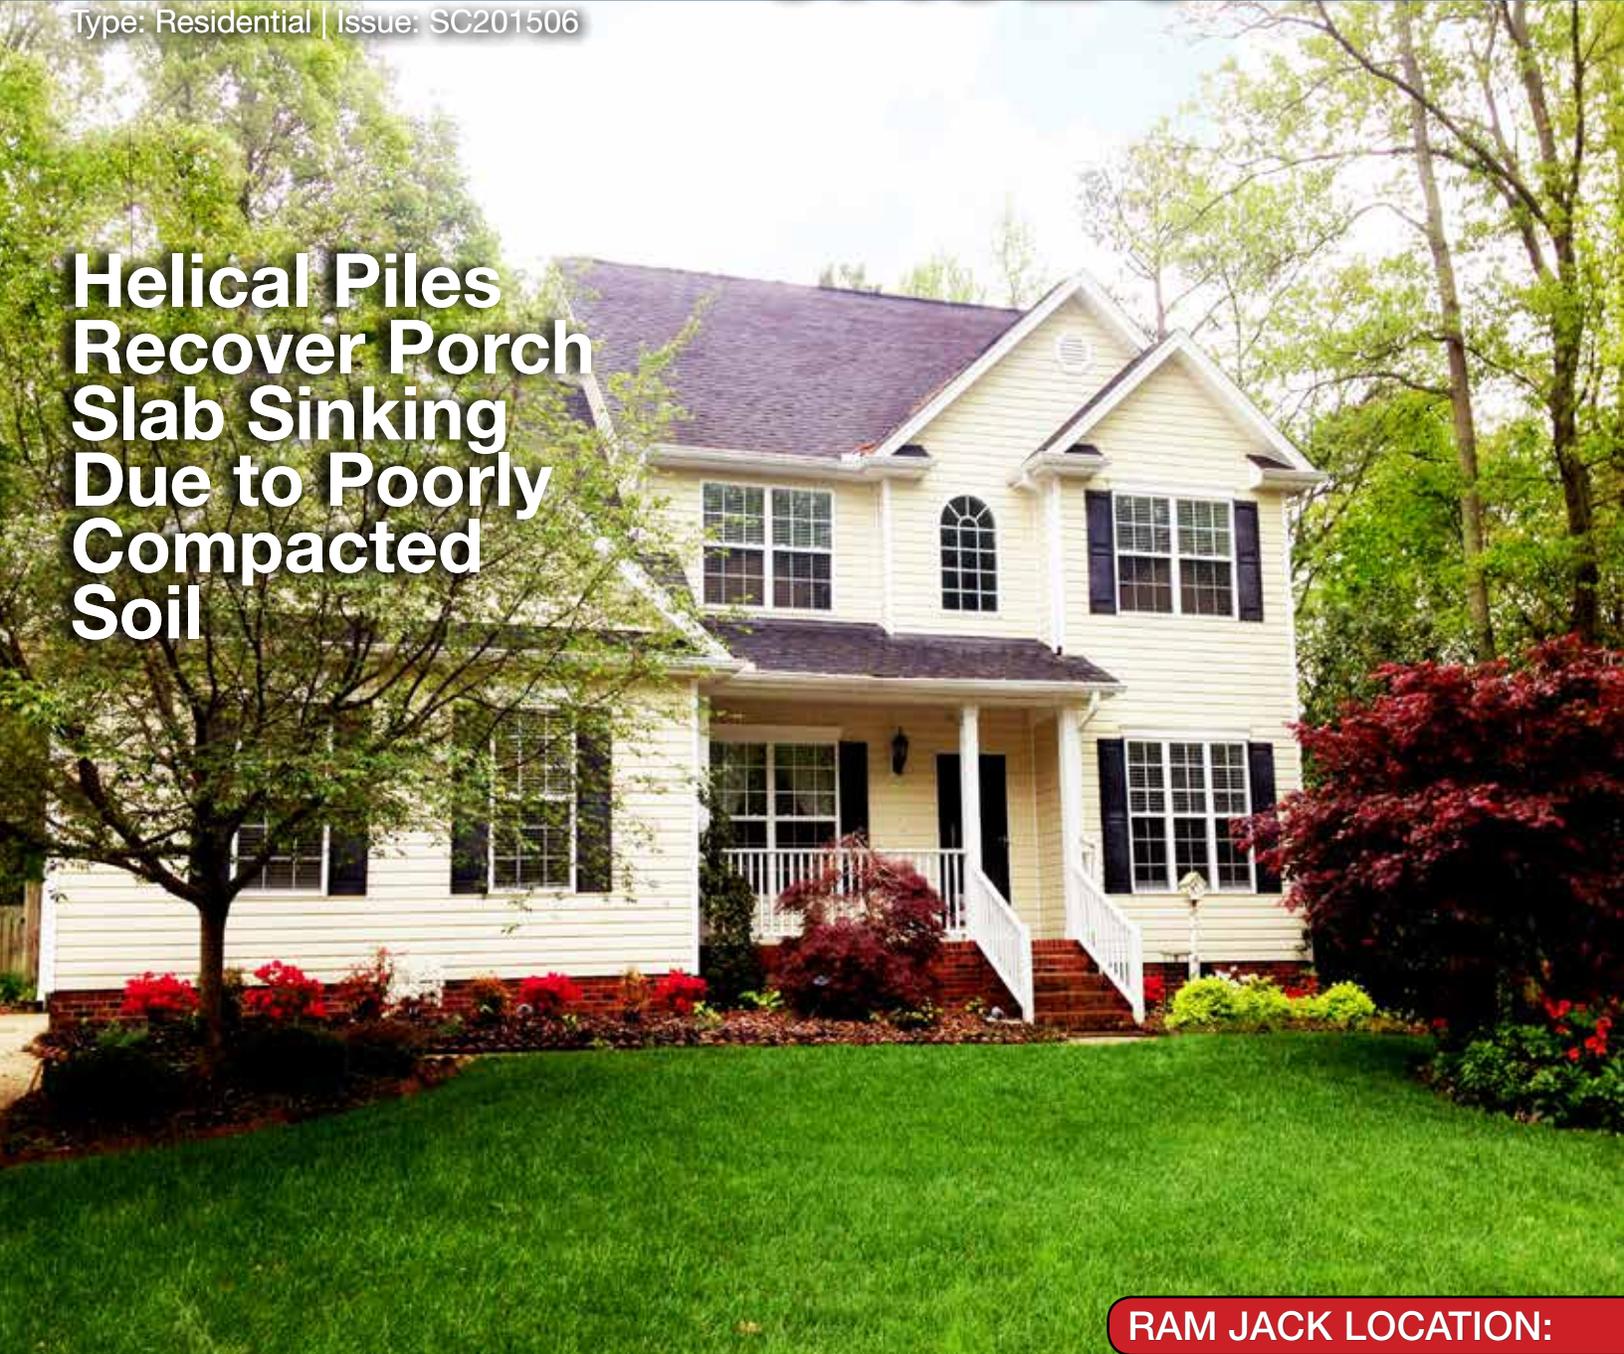
The homeowners contacted Ram Jack South Carolina when they noticed the concrete floor of the porch, which had once been level, had begun to settle. Ram Jack sent a foundation specialist, who found that the porch slab had fallen as much as 2 in. at the center. Presumably, the soil beneath the porch had not been properly compacted prior to its con-

struction, and with the increased weight of the concrete slab, the soil settled, bringing the porch with it.

After a thorough inspection, Ram Jack South Carolina professionals proposed the installation of three helical piles. These piles would be used to lift and stabilize the sinking concrete slab.

When the crew arrived to install the piles, they noticed a new stair-step crack in the front, right corner of the concrete slab, indicating that the corner of the porch was settling as well. Knowing the corner of the porch slab would also need to be repaired, the crew came up with a new plan. In addition to installing the three proposed helical piles as scheduled, the crew added two helical piles to the porch's corner a few weeks later. When the job was finished, the porch was lifted to maximum practical recovery, the cracks were lessened, and the stability of the porch matched the beauty of the home.
