# Ram Jack<sup>®</sup> Case Study

Manufacturing Plant • Phoenix, AZ

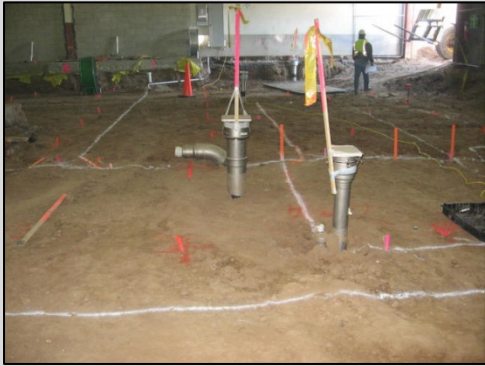
**Situation:** This structure was being remodeled to accommodate the addition of new heavy equipment. It was determined that to support the load a 16" slab with a deep foundation system would be required.

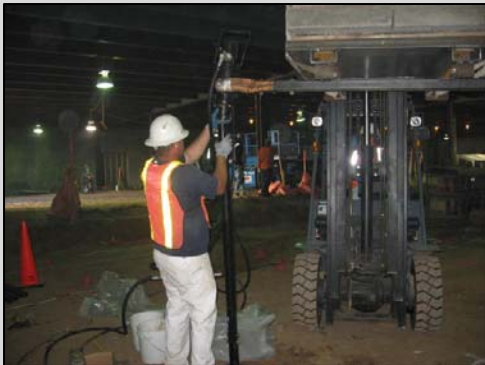
**Conclusion:** Because of the soil conditions they were concerned that any movement would damage the expensive plumbing system below the floor. Over excavating enough soil to resolve this issue would be a challenge inside this existing structure. There was no room to bring in the equipment that would be needed to install caissons.
