# 2016 CASE STUDY

## Failing Retaining Wall Supported with Ram Jack Tieback System

# HEREDIA WAL-MART | TIEBACKS STRAIGHTEN LEANING WALL

Heredia, Costa Rica

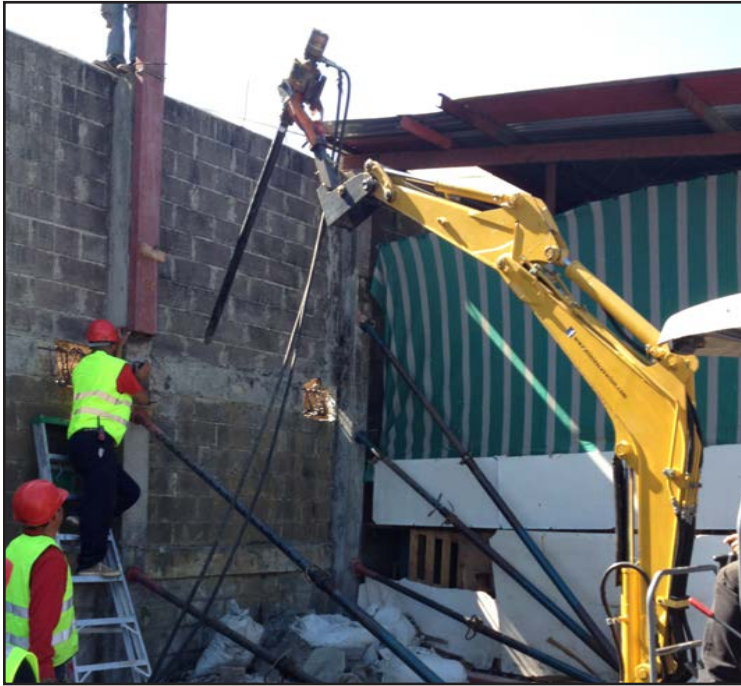
Built aside an existing retaining wall that separated the Heredia Wal-Mart from its neighbors, the excavation process during construction resulted in soil pile-up against the wall, causing it to lean toward the adjacent property. Complicating the situation was a large water tank near the wall that would need to be avoided during any work. In addition, the concrete used

to build the wall was sub-par quality and limited in strength, likely due to being hand-batched many years ago. Temporary shoring beams were installed immediately to ensure the safety of the work crew during any and all construction.

Ram Jack Centro America proposed excavating the soil near the wall, installing tiebacks through the existing columns supporting the wall, and installing new construction brackets so further tiebacks could be fastened. The tiebacks would both straighten the leaning wall and improve its structural integrity.

Using a core drill to bore holes through the columns and a jack-hammer to chew through needed sections of the wall, Ram Jack Centro America set itself up for success. Once work started, it became clear that the structural integrity of the wall would not allow it to be moved. Instead of straightening it, Ram Jack Centro America decided to stabilize it in place. When finished, ten piles were installed to an average depth of 24 ft., and numerous tiebacks were installed to support the wall, providing the structural support needed to restore stability. The contractor and engineer were more than pleased with the results. In fact, the contractor has used Ram Jack Centro America for two subsequent jobs!

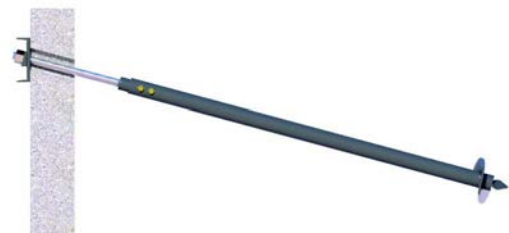
**Typical Applications** • Ram Jack's 2 7/8" dia. helical lead sections can be used in either tension or compression due to its unique internal threaded connection. Internal threaded connection makes a smooth homogenous pile.
