Installer: Florida Foundation Repair · Jacksonville, FL · 877.726.6372

The Chick-Fil-A lodge overlooking the Sugar Mill Golf Course in New Smyrna Beach, FL was experiencing signs of foundation settlement. There were stair-step cracks and wall separation along the entire exterior of the building facing the lake. The property management company reached out to Ram Jack for a minimally-invasive solution to their settlement problem.

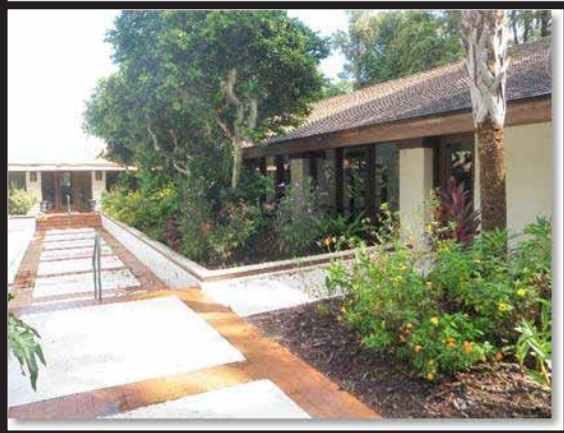
With an ultimate load of 40 kips and allowable of 20 kips, S.T.C. Properties requested that Ram Jack provide a solution to meet load requirements. (44) Ram Jack 2 7/8 Helical pilings with a 10"-12" helix configuration were installed at the Chick-Fil-A Lodge by Florida Foundation Repair.

Remedial helical pilings with standard brackets installed along the exterior of the lodge succeeded in almost completely closing the existing cracks. Ram Jack's minimally invasive and quick installation helped stabilize the Chick-Fil-A Lodge, allowing them to re-paint and then making existing cracks virtually invisible.
