CASE STUDY

COVINGTON ELECTRIC COOPERATIVE

ANDALUSIA, AL

Installer: Alabama Ram Jack • Decatur, AL • 877.875.2171

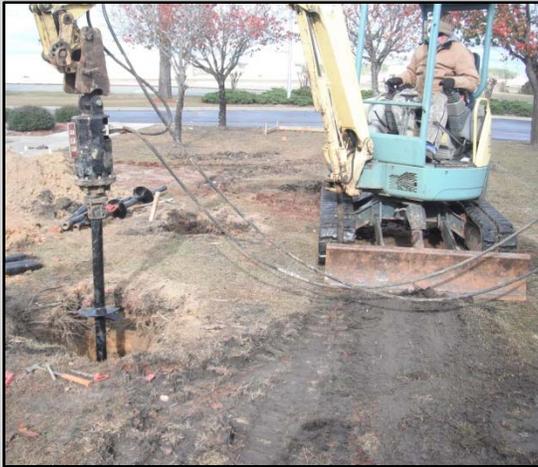
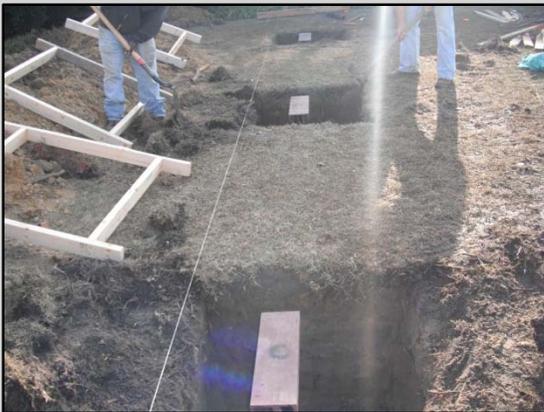
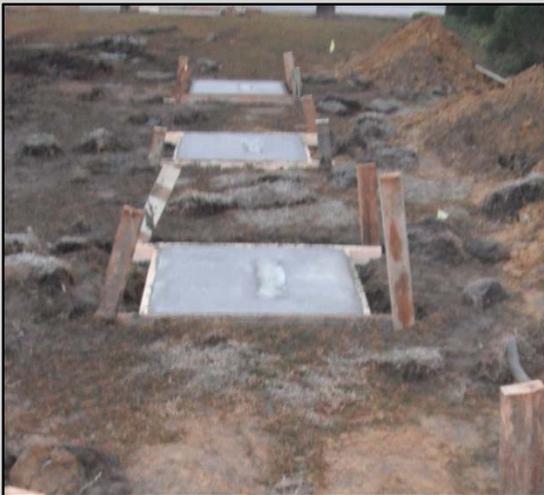
How Ram Jack was Involved: In order to resist the wind uplift forces, deep-seated helical piles were needed. Alabama Ram Jack was contacted to evaluate the application. Originally the piles were specified to be a relatively small size, 1 1/2 inches in diameter. After reviewing the soils report, the engineers at Ram Jack quickly discovered small diameter piles, would not suffice for this site. In particular, the soils report showed there is a relatively stiff, sandy clay soil at depths of 6 to 8 feet, which the specified smaller-diameter piles would not be able to penetrate, and then the tension-only piles would be vulnerable to pull-out. The Ram Jack analyses showed that our 2 7/8 inch diameter piles with a triple 8"/10"/12" helix would be needed to penetrate the near-surface stiff soils and reach the depths needed to attain the uplift resistance. Alabama Ram Jack was awarded the job primarily because of their expertise in evaluating the situation in advance.

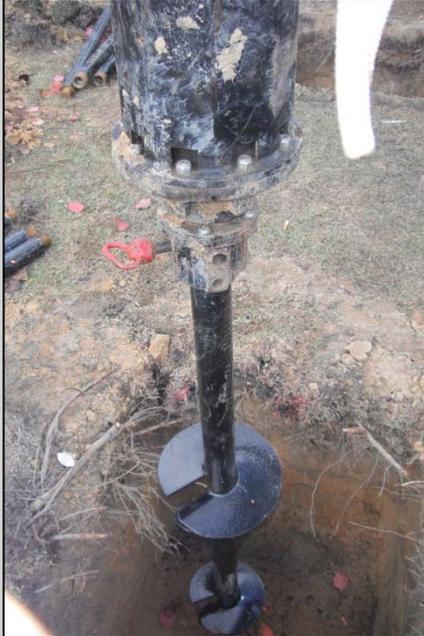
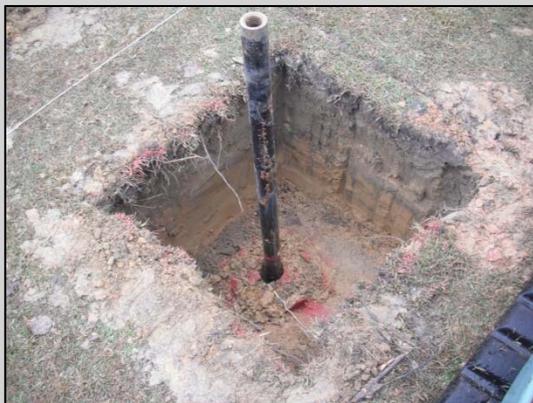
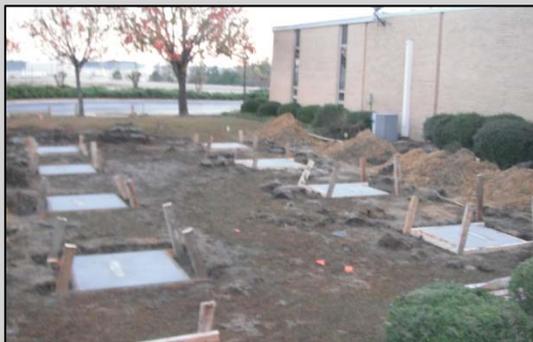
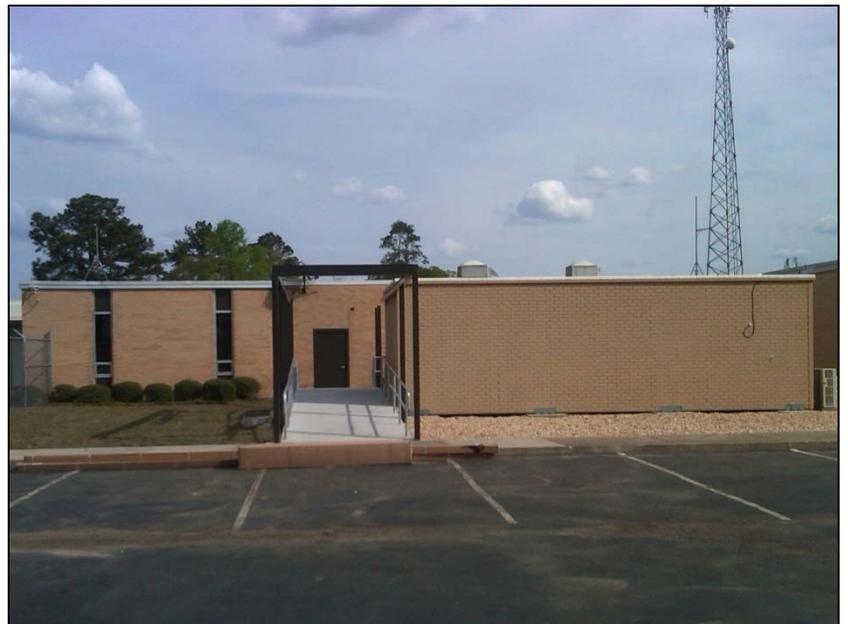
This job also posed a challenge in that the building was prefabricated with steel plates on the bottom for welding to the helical pile brackets that were installed in advance of the building delivery. Therefore, the installation had to be very precise with only a few inches tolerance. Our production crew was up to the task and the building was placed atop the brackets and welded to them to provide the necessary uplift resistance. The electric cooperative now has additional assurance that their operations will not be disrupted during tornadic weather.
