LAKEFRONT HOME PROTECTED
FROM SETTLEMENT **THREAT**

WA201803

FOUNDATION SETTLEMENT NO MATCH FOR RAM JACK HELICAL PILES

BELLEVUE, WASHINGTON

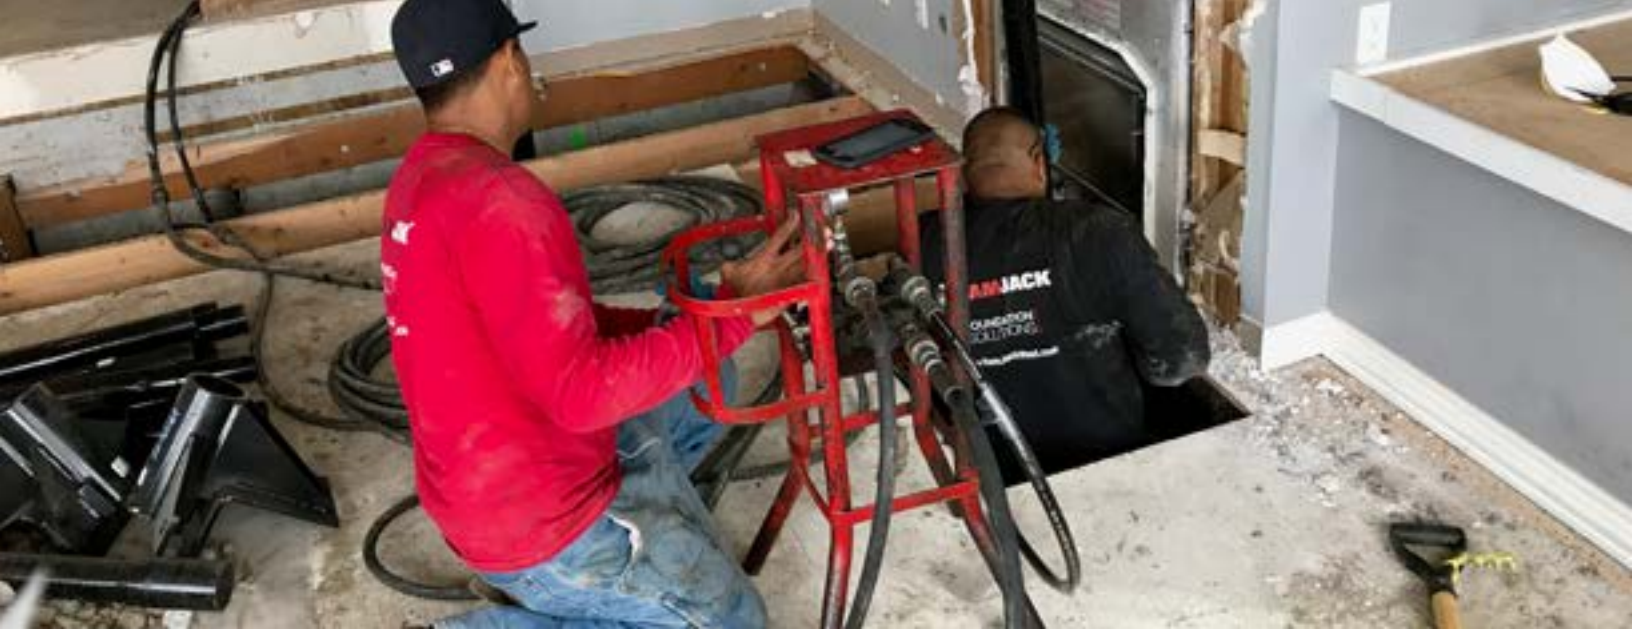
This home sits only 20 ft. from the shoreline of Lake Sammamish, which causes the water table to run directly underneath the property. Changes in the water table, coupled with expansion of the home through multiple additions over time led to serious settlement, leaving large cracks throughout the slab foundation.

Ram Jack West proposed a solution that would restore the structure which had settled up to 5 in. in some areas.

Working with Stark Foundations, a local engineering firm, Ram Jack implemented helical piles, tie-back anchors, and driven piles to stabilize the structure and provide solid support from the strong strata deep within the ground. Piles were installed at an average depth of 34 ft. into the earth, providing necessary support. Utilizing 24 helical piles and 50 driven piles, the home was lifted 4 in. and the owners' fears were relieved. When speaking of our involvement in the project, the customer told us, "Thanks for all of your exceptional work..."

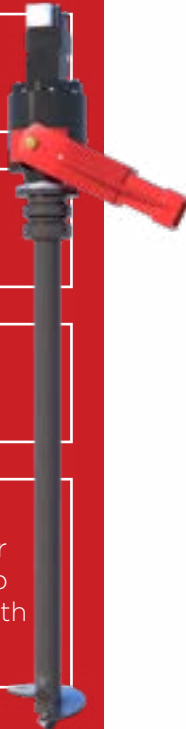
Total Number of Piles
24

Product Used
2 7/8" Helical Piles

Product Type
Remedial - Helical

Typical Applications
Ram Jack's 2 7/8" diameter driven steel pilings are slip jointed allowing for a smooth and homogenous pile.
