# SAINT JOSEPH CATHOLIC CHURCH

CASE STUDIES | TX202104

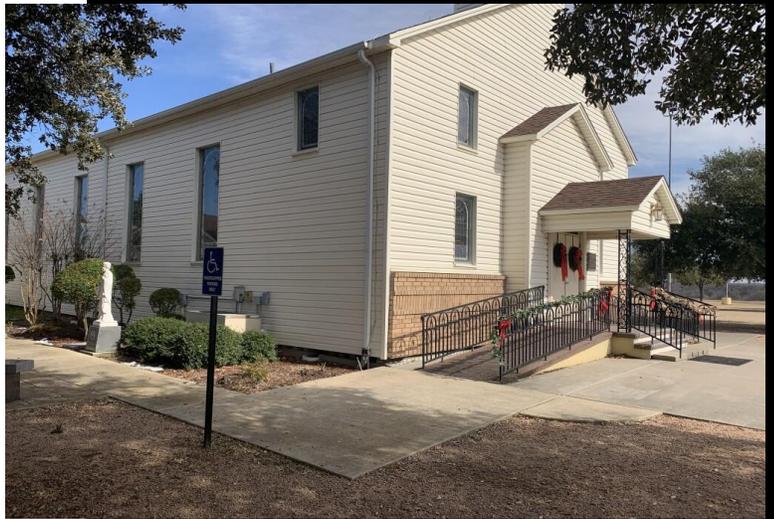
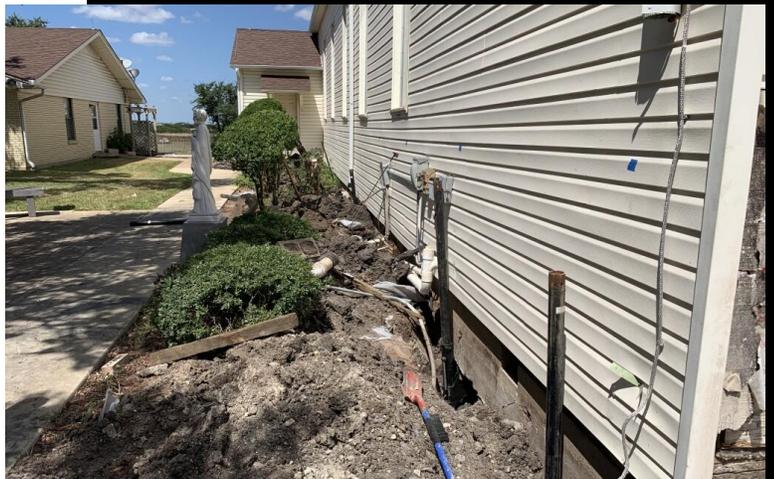
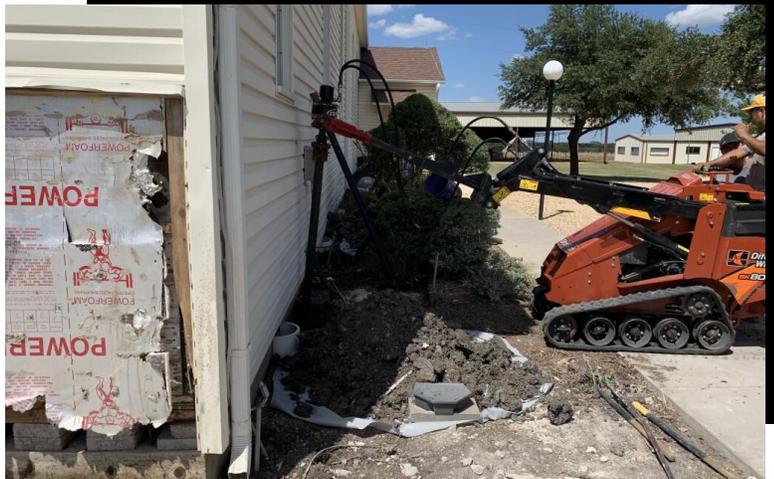
The church consisted of a pier & beam foundation with a concrete perimeter beam and wood floor system. The beam and floor system were supported on concrete piers that had shifted and failed. Other companies attempted to repair the foundation over the years with very poor results as their solution was to raise the wood beams and exterior walls off of the concrete perimeter beam and place their load on concrete blocks bearing on the surface of the soil.

Heavy rains during the spring and early summer of 2021 delayed the start of this project. When the weather finally cooperated, Ram Jack crews were able to install the required helical piles and raise the exterior beam 12 to 15 inches.
